Glitched on Earth by Humans: A Black-Box Security Evaluation of the SpaceX Starlink User Terminal

Lennert Wouters

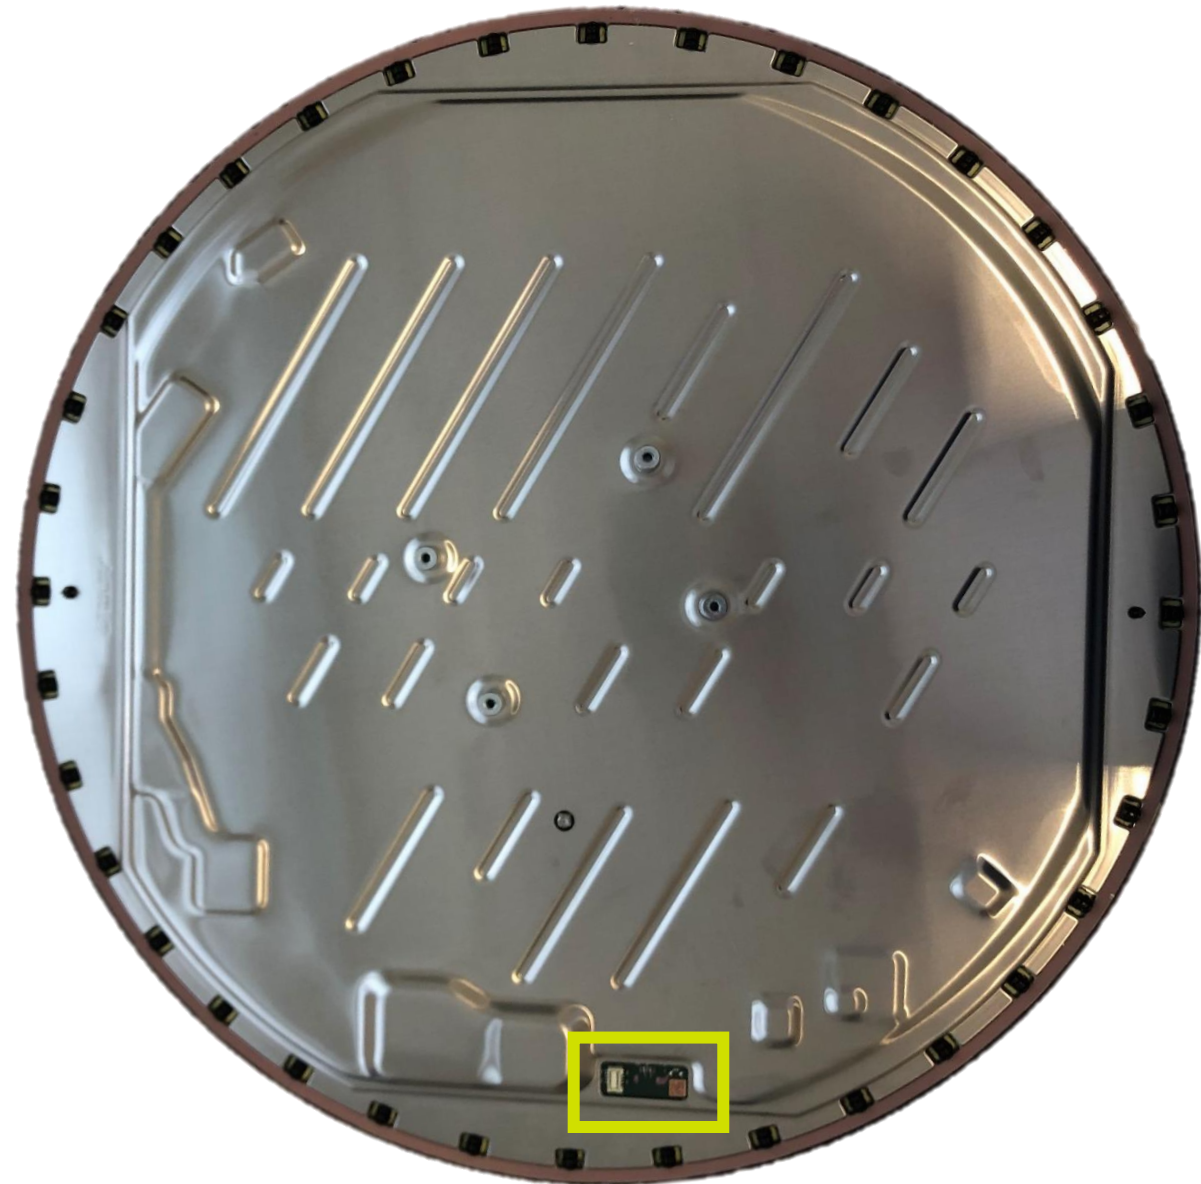
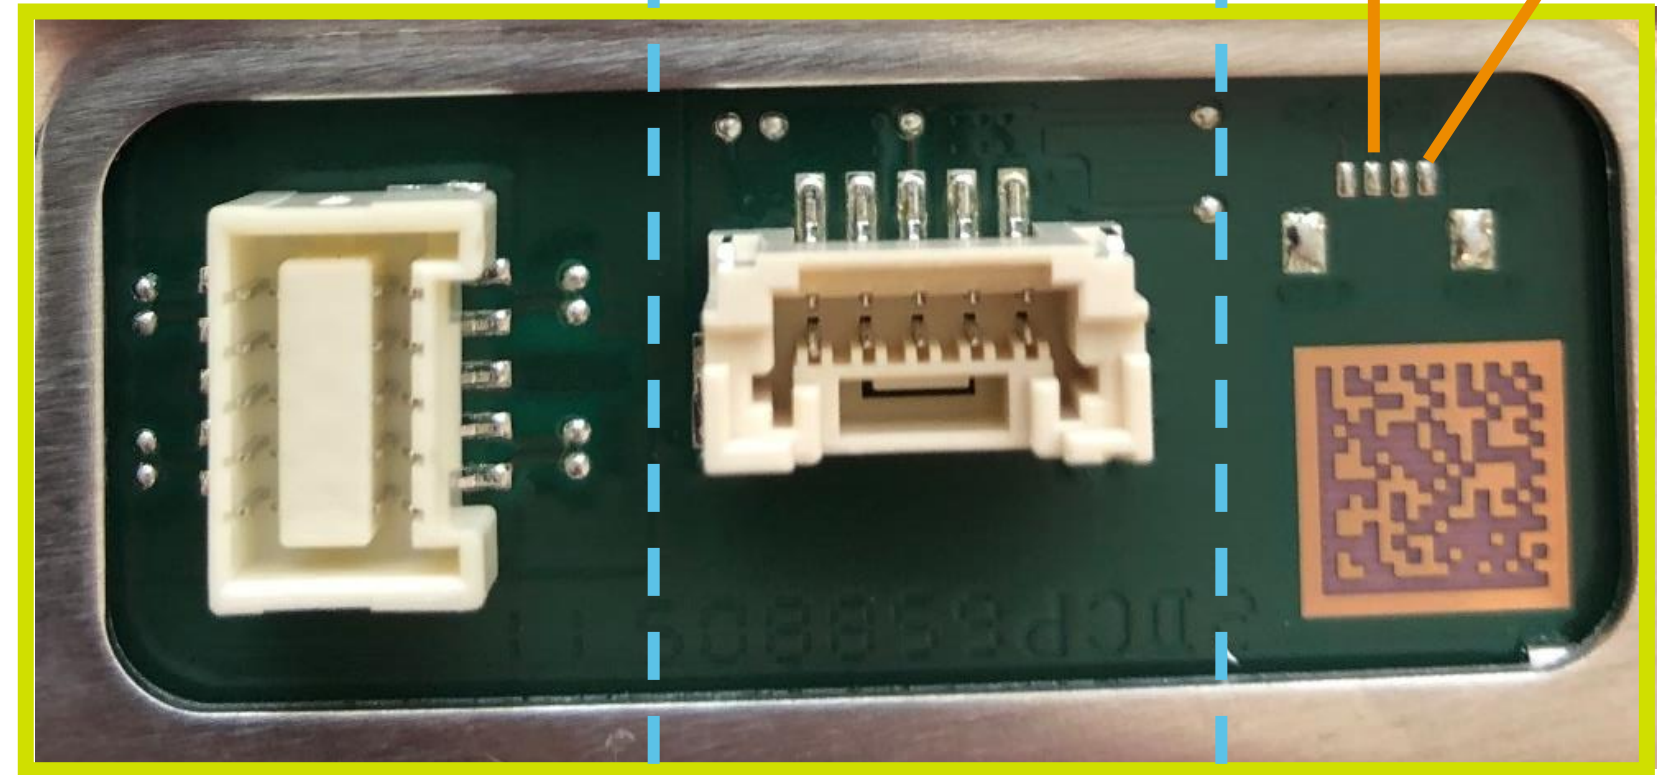
Accessible connectors on V2*

ethernet + power

JST BM10B-ZPDSS-TF(LF)(SN)

motors

JST BM05B-ZESS-TBT(LF)(SN)

UART

UT TX UT RX

*V1 hardware had an extra connector, V3 does not have easily accessible connectors
<https://t.me/learningnets>

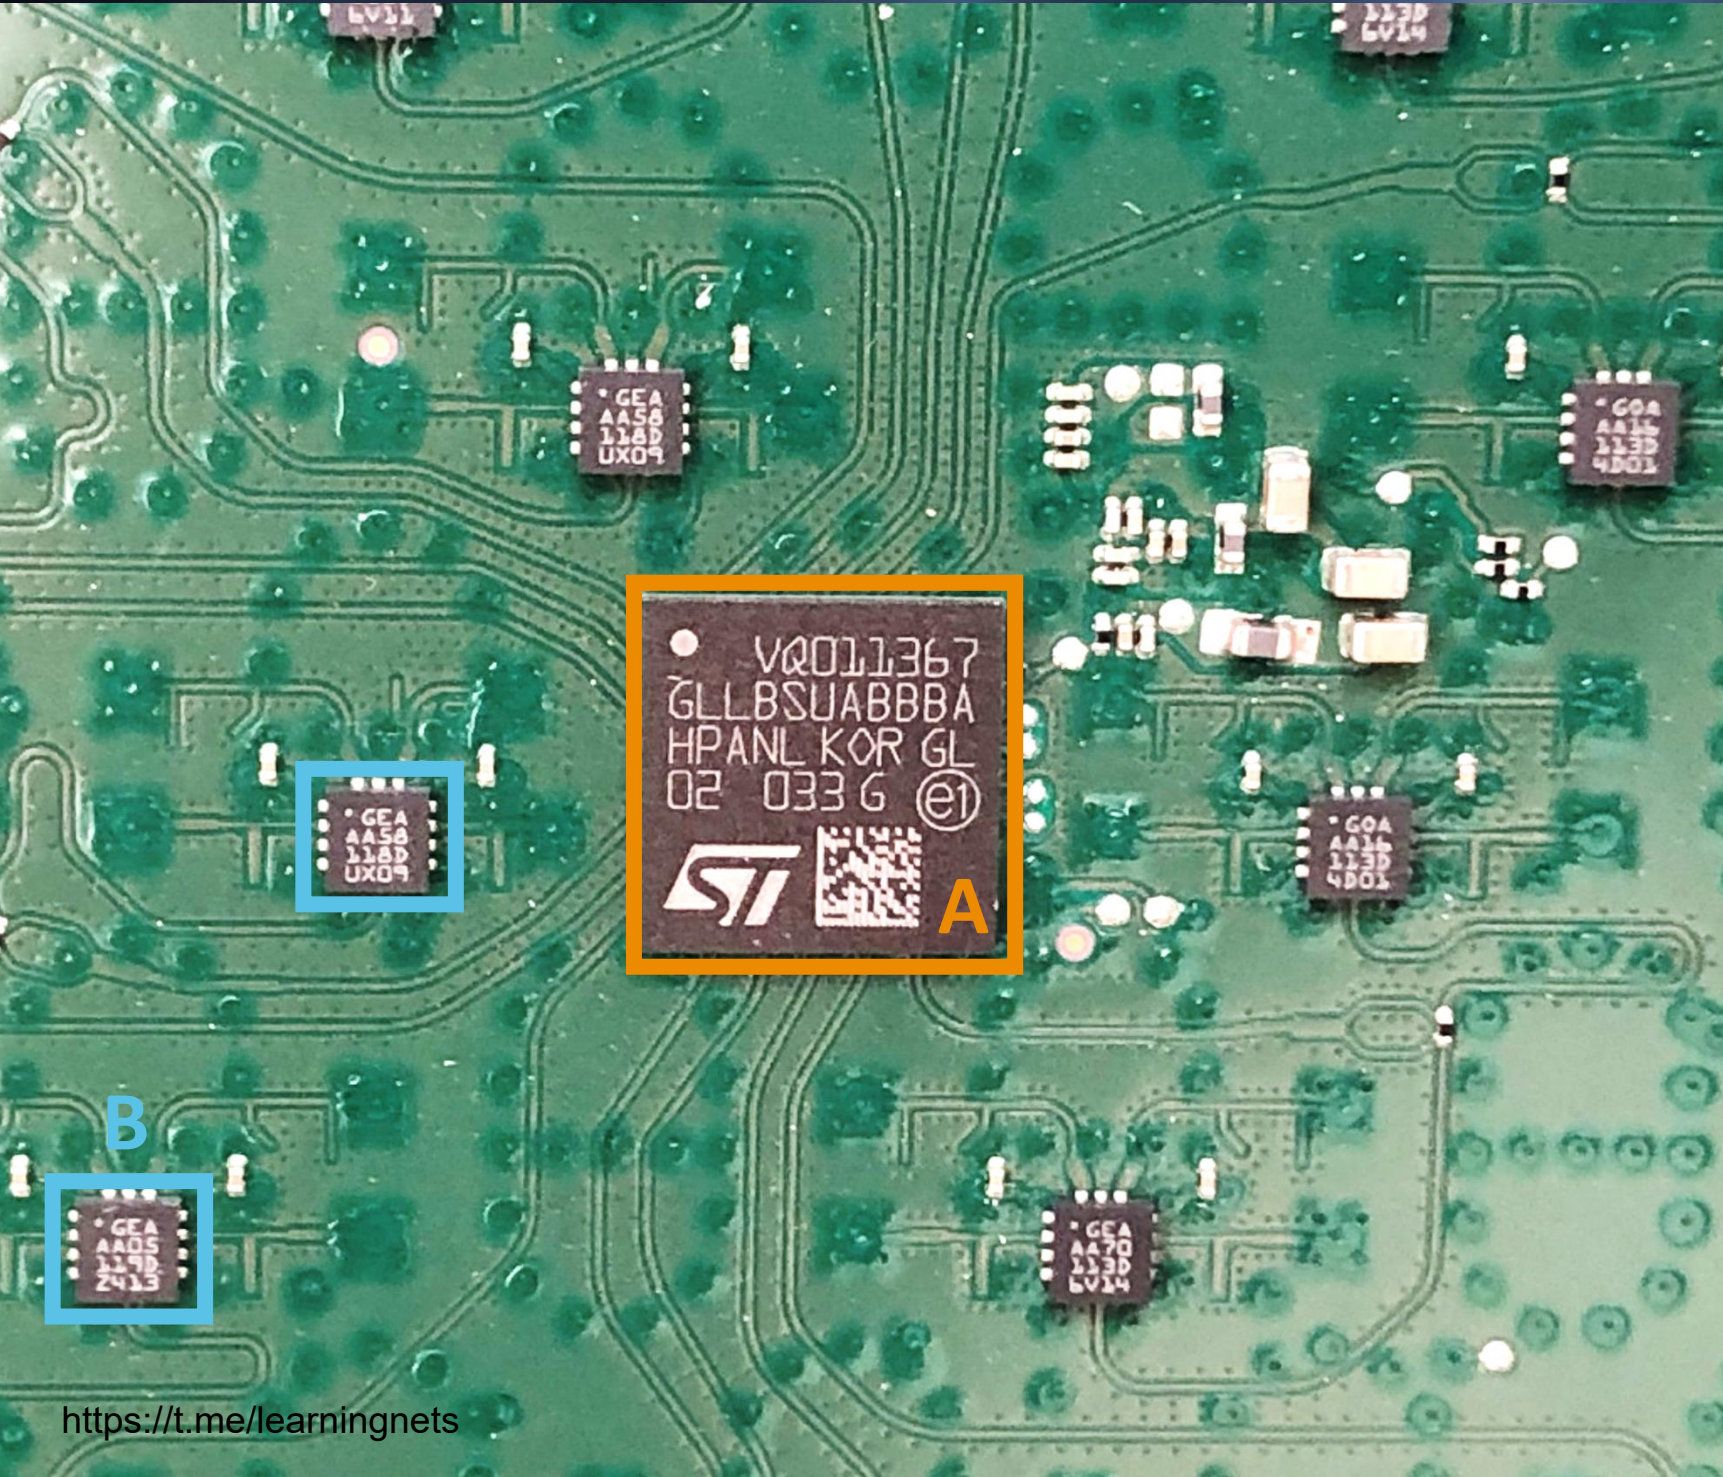
RF Components

- (A) Digital BeamFormer (DBF)
 - STM GLLBSUABBBBA
 - Codename: **SHIRAZ**
- (B) Front-End Module (FEM)
 - Codename: **PULSAR(AD)**
- V2 hardware and up:
 - 1 DBF → 16 FEMs

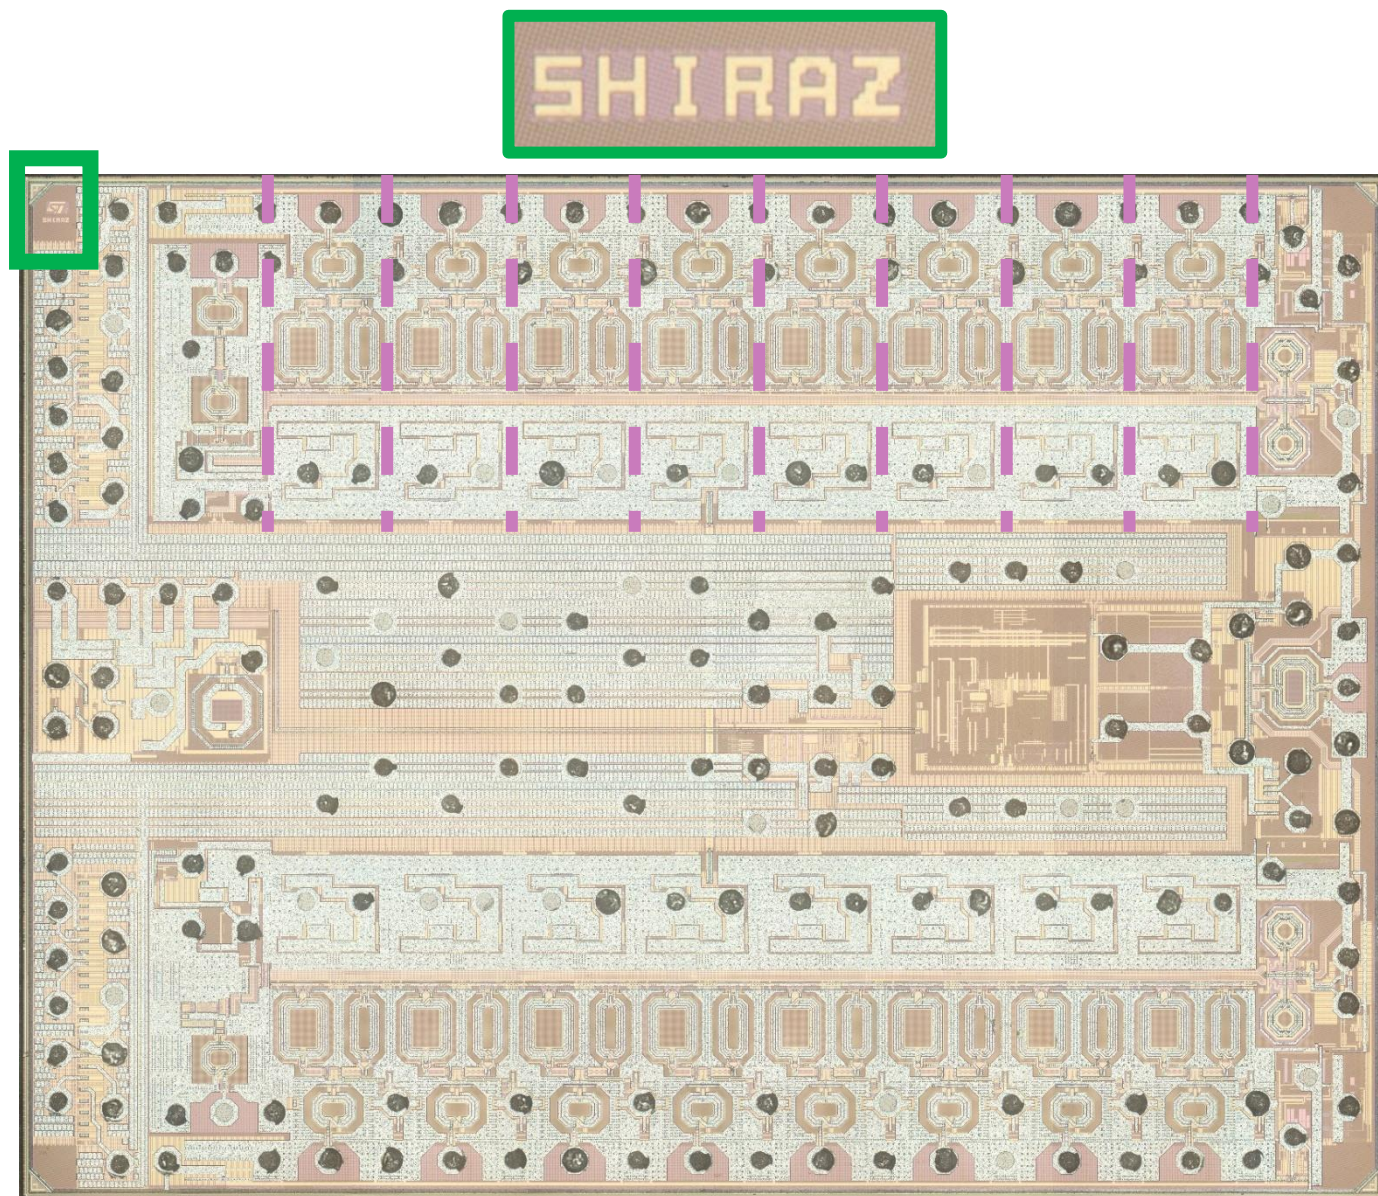
SHIRAZ

siliconpr0n.org/archive/doku.php?id=mcmaster:spacex:gllbsuabbba-shiraz

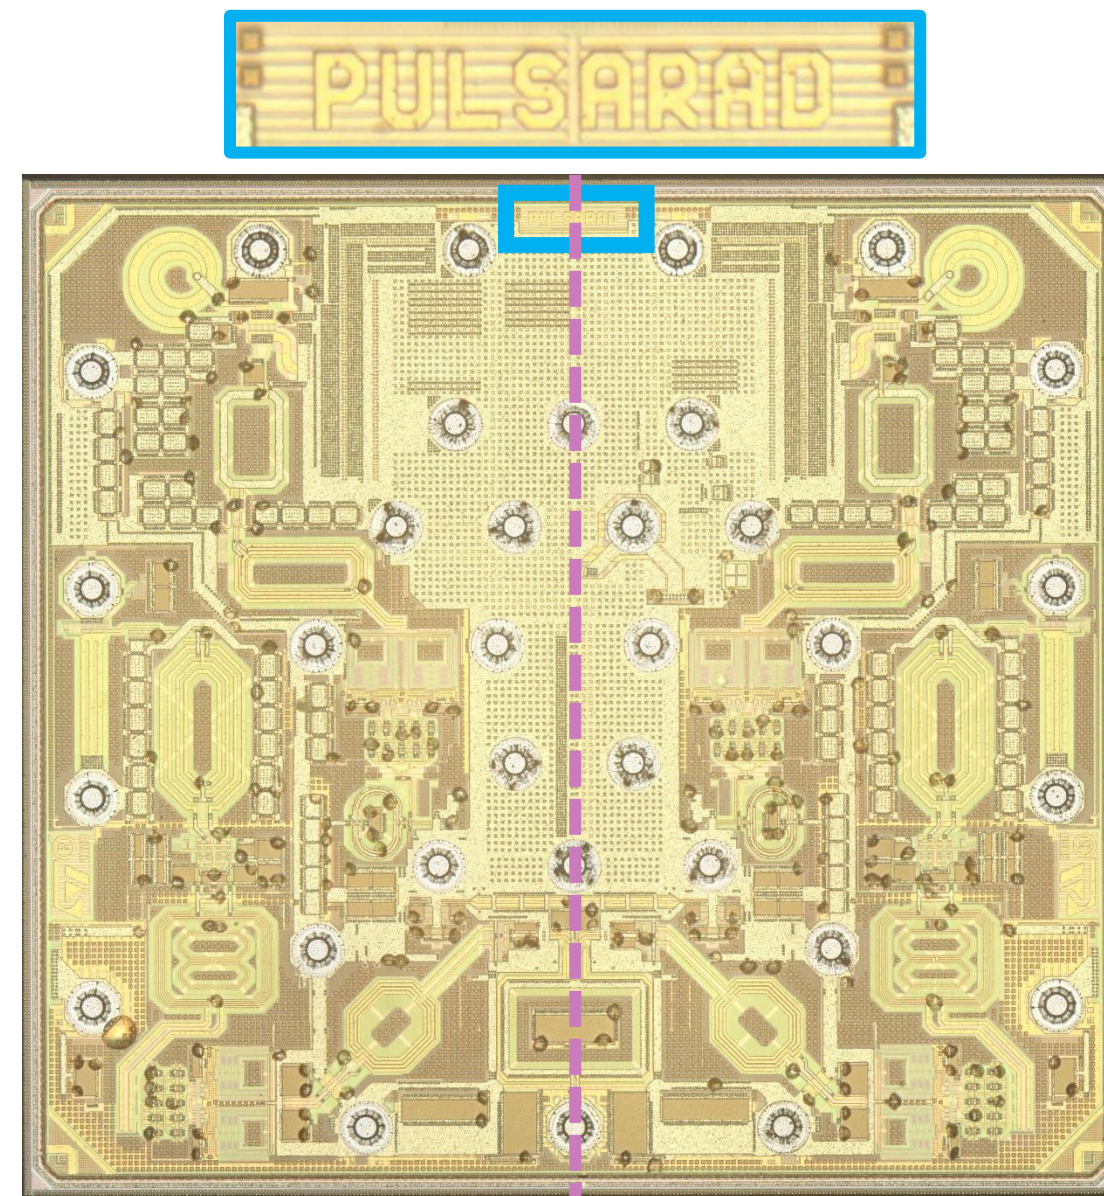
PULSARAD

[id=mcmaster:spacex:gea-aa12-109d-tg02-pulsarad](https://siliconpr0n.org/archive/doku.php?id=mcmaster:spacex:gea-aa12-109d-tg02-pulsarad)

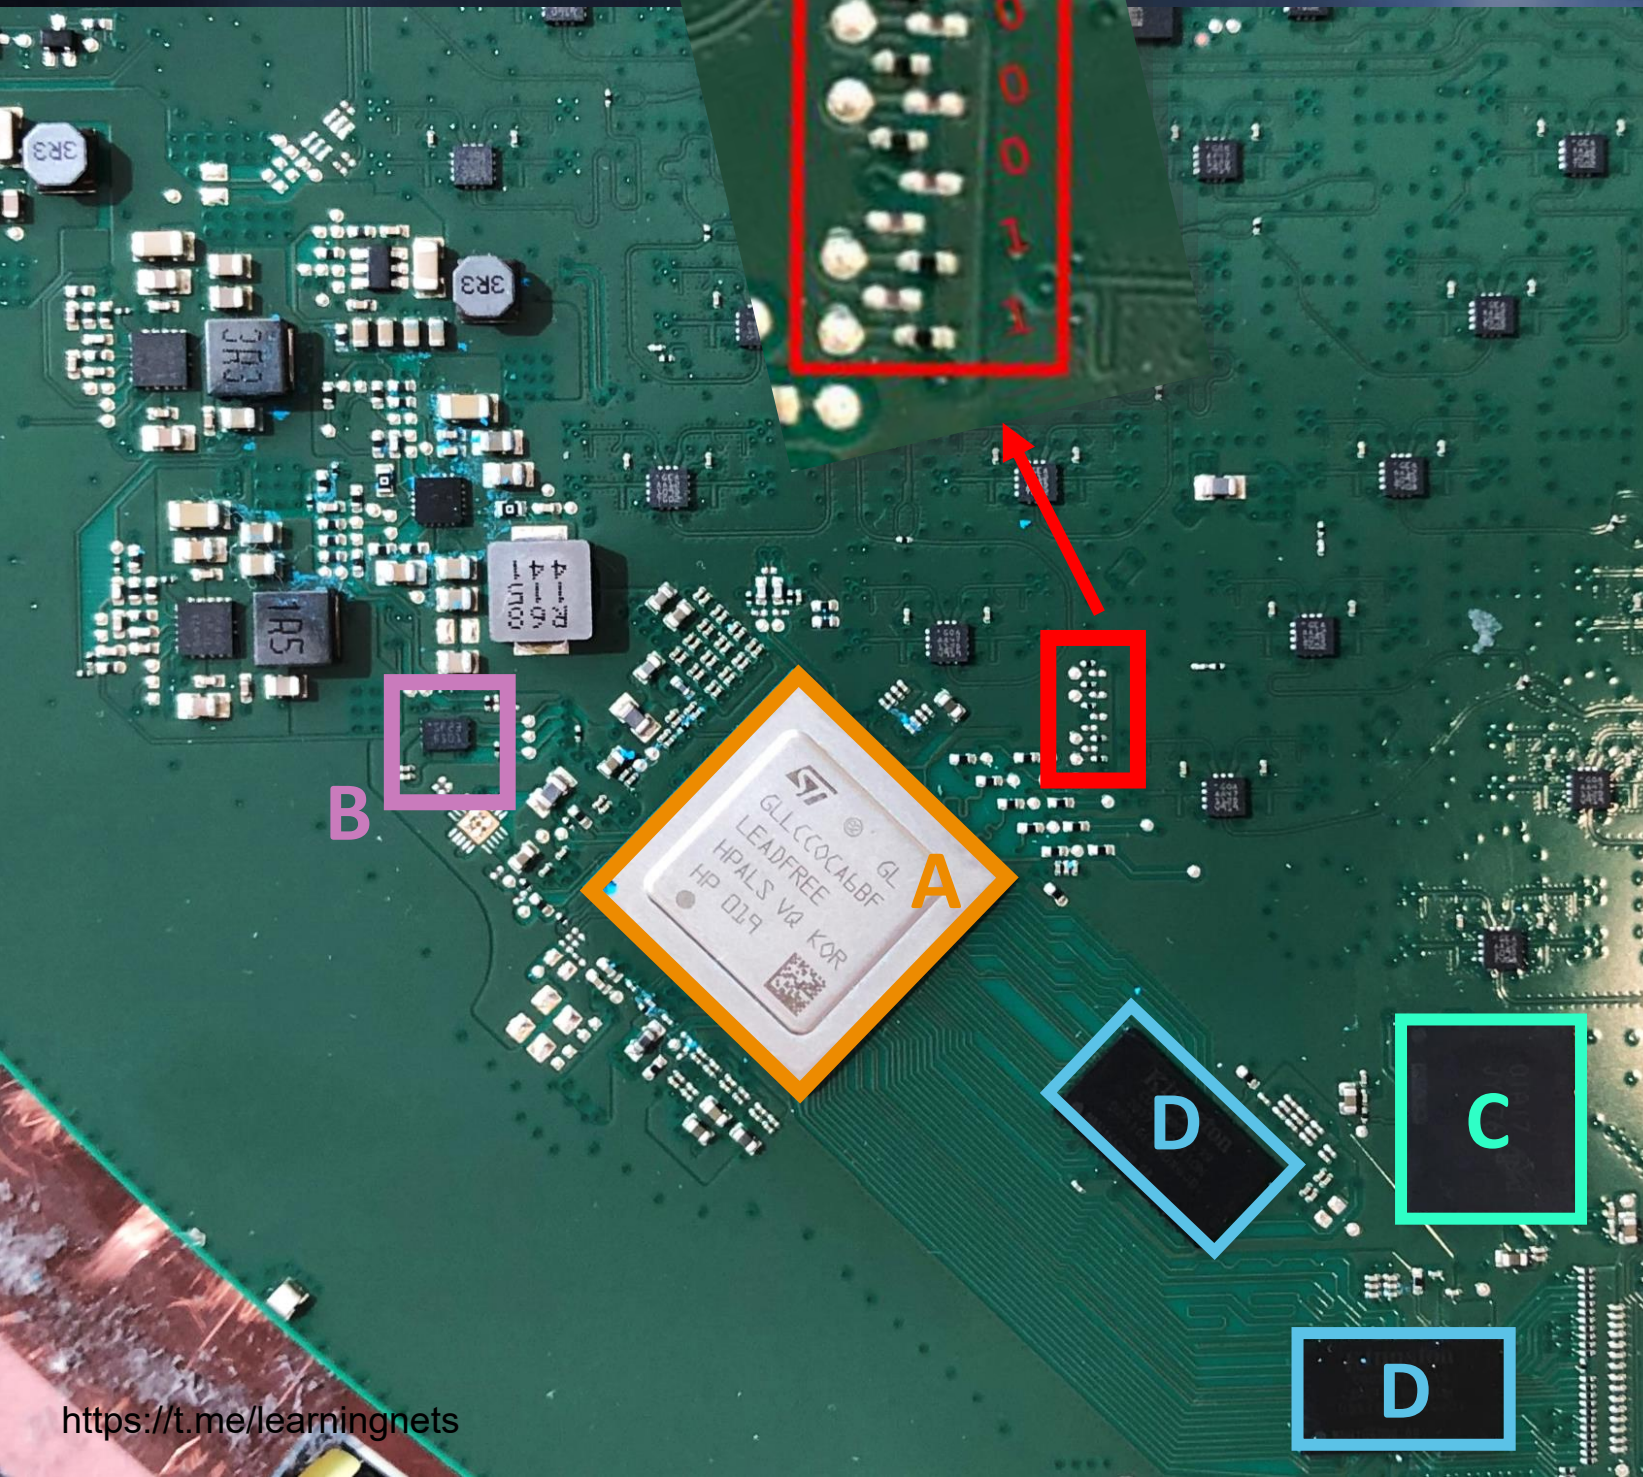
- (A) System-on-Chip
 - Custom quad-core ARM Cortex-A53
 - ST Microelectronics
 - GLLCCOCA6BF (cut 3?)
 - GLLCCODA6BF (cut 4?)
 - Codename: **CATSON**
- (B) Secure Element
 - STM STSAFE-A110
- (C) 4GB eMMC
- (D) 2 x 4Gbit DDR3

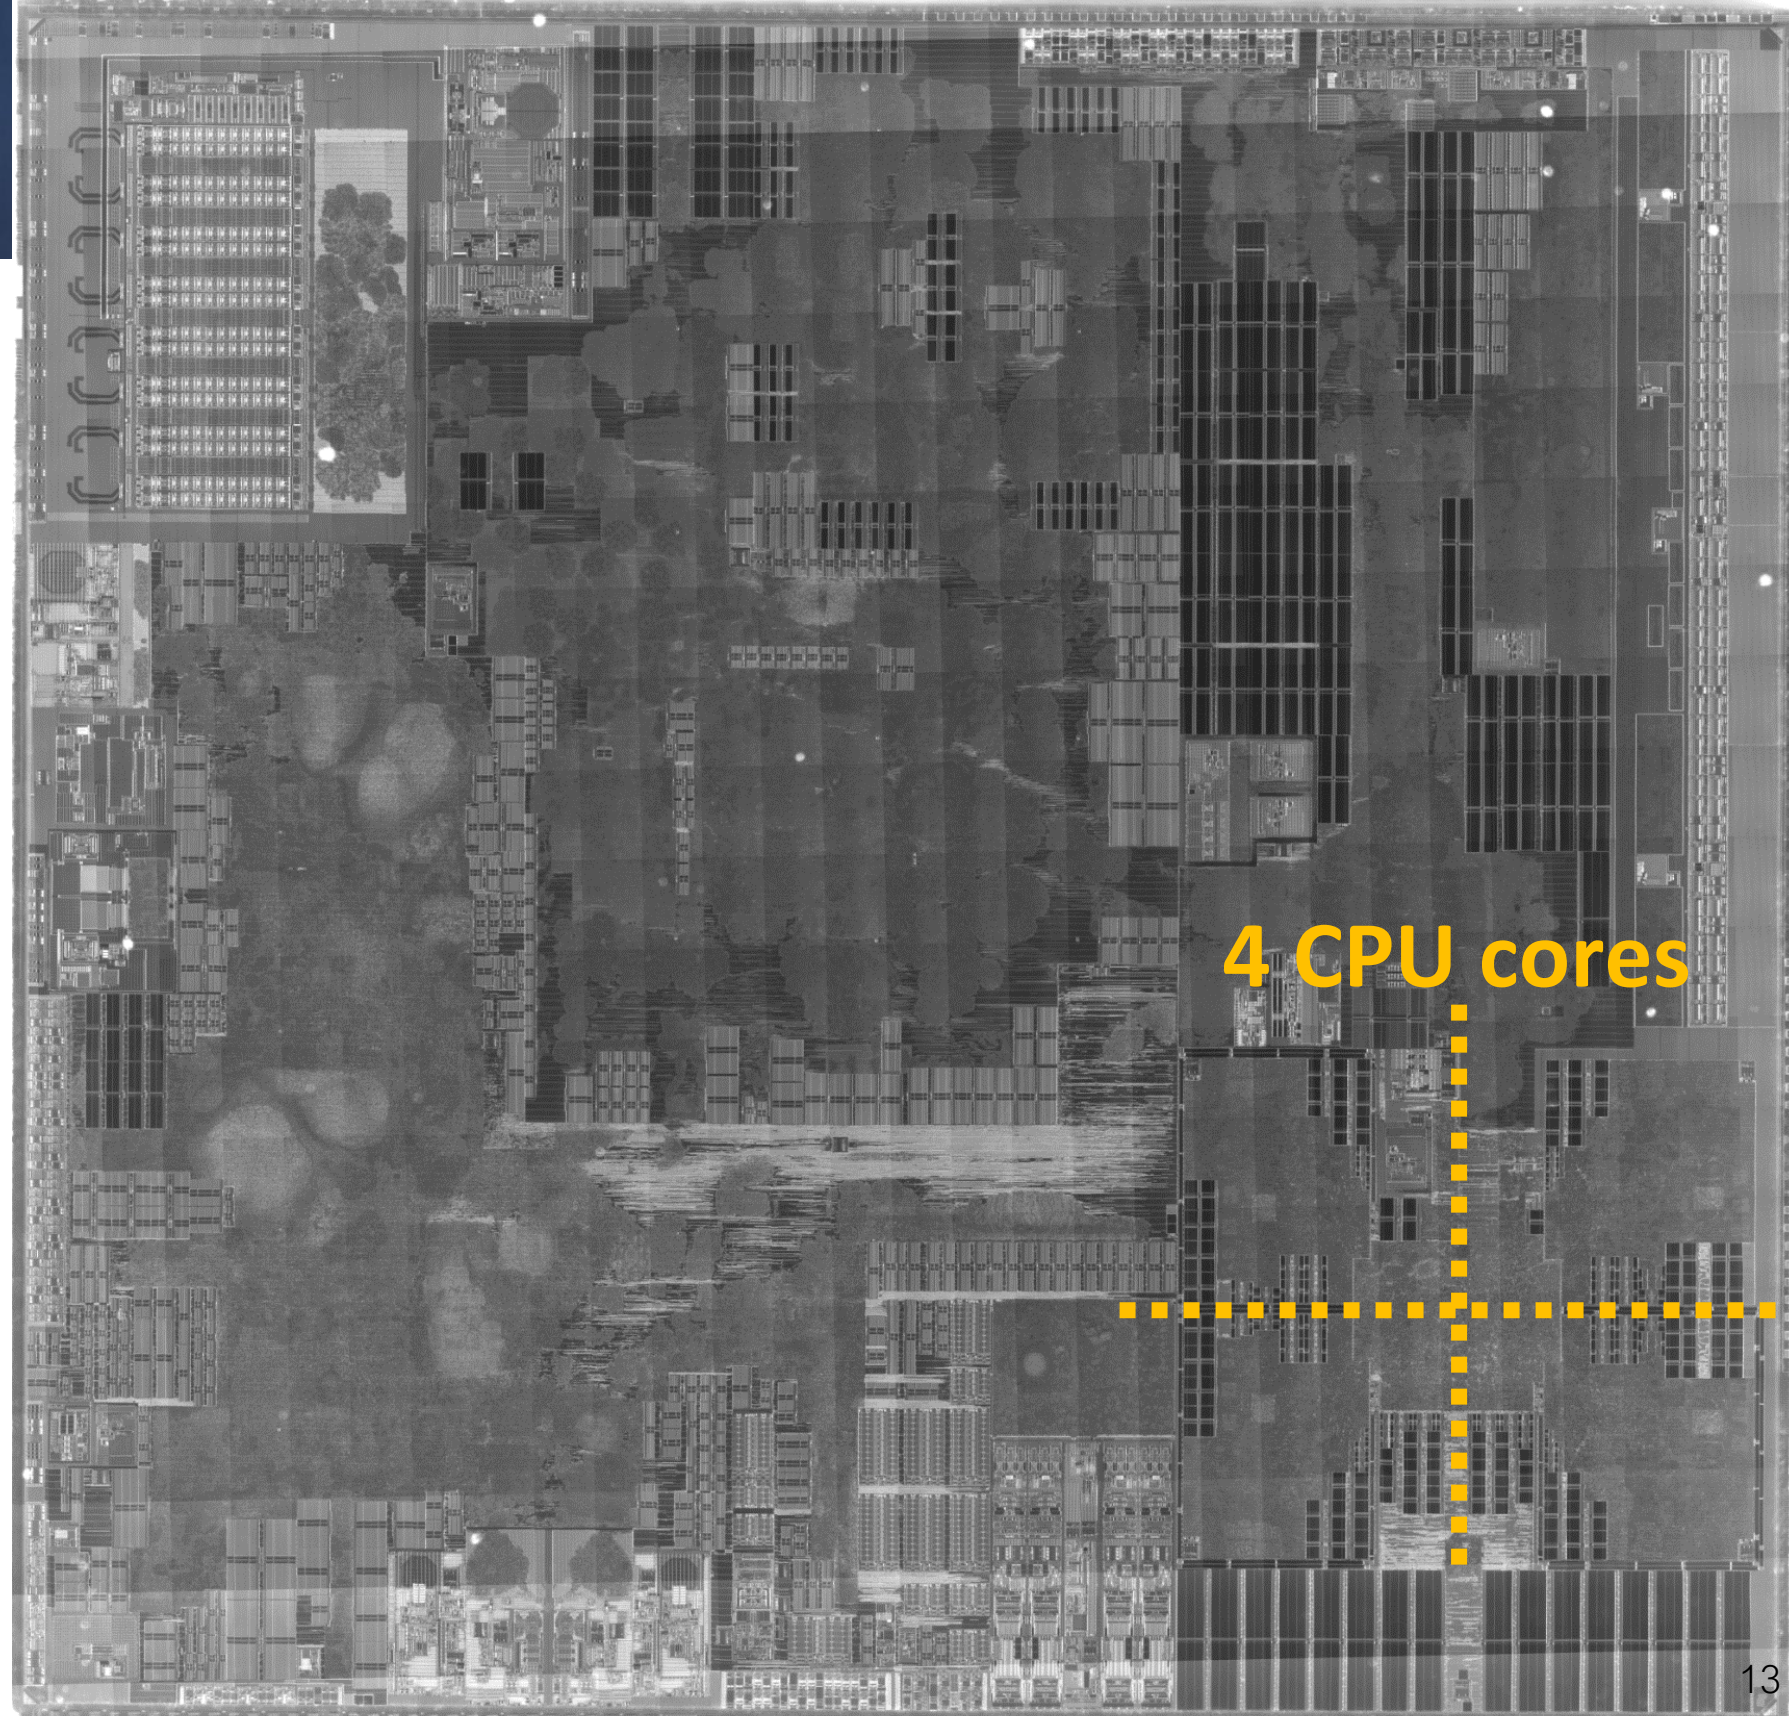
- through substrate image
 - GLLCCOCA6BF (cut 3?)
 - Thorlabs NIR camera
 - Mitutoyo NIR objective 50x
- Can help narrow down interesting locations for some physical attacks
- Full resolution version will be available on siliconpr0n.org!

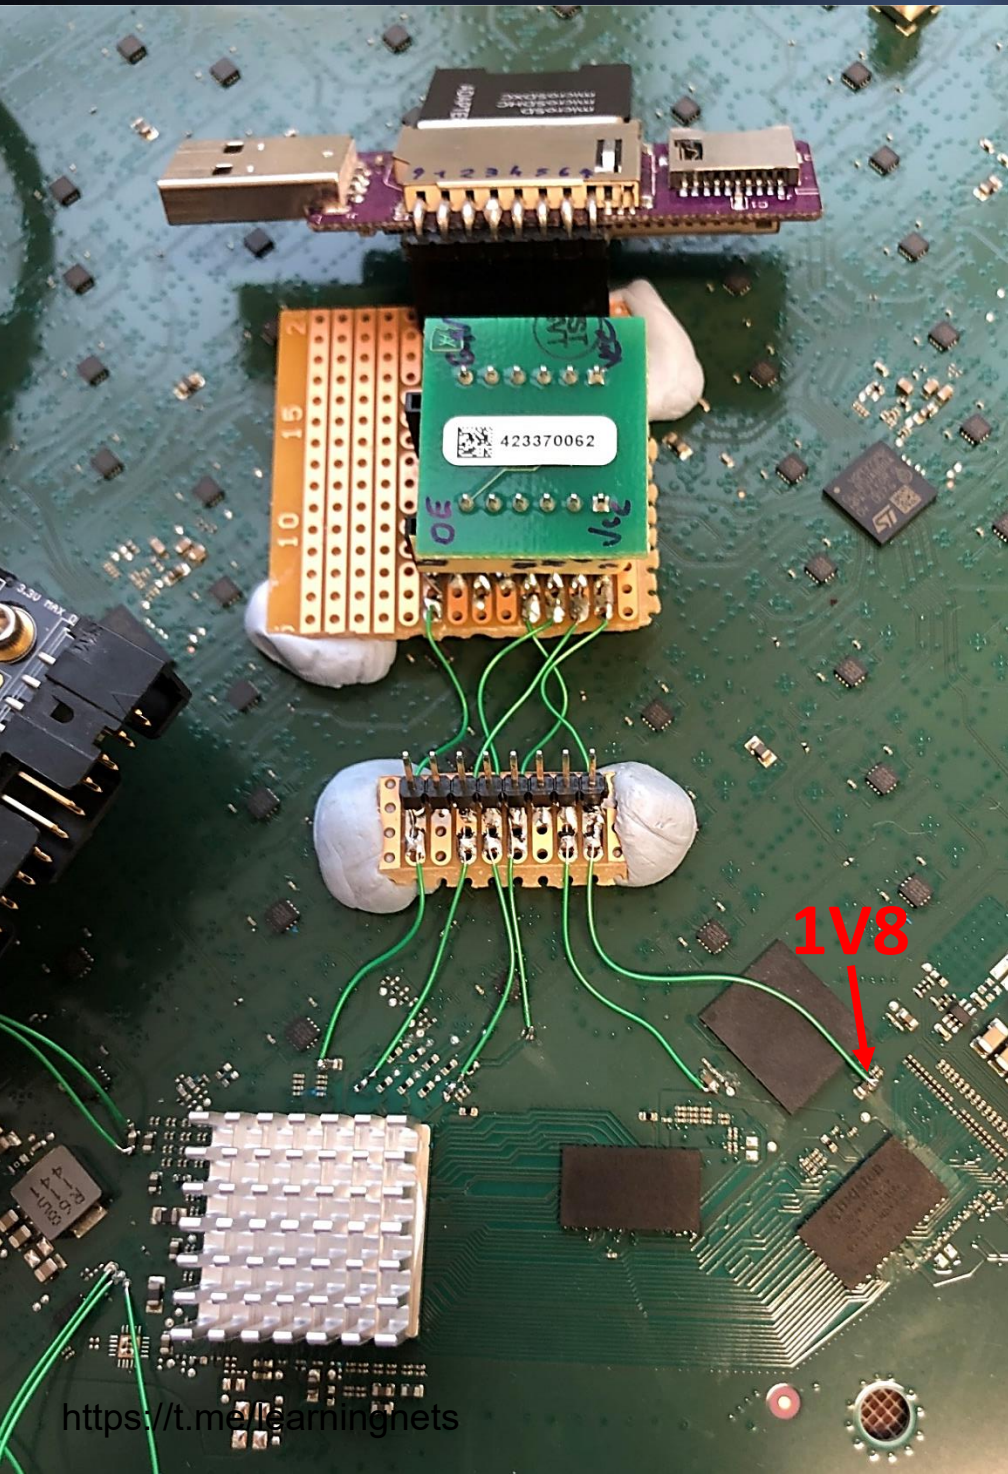
Reading eMMC in-circuit

SD card reader

TXS0202EVM
Level shifter

← What I did

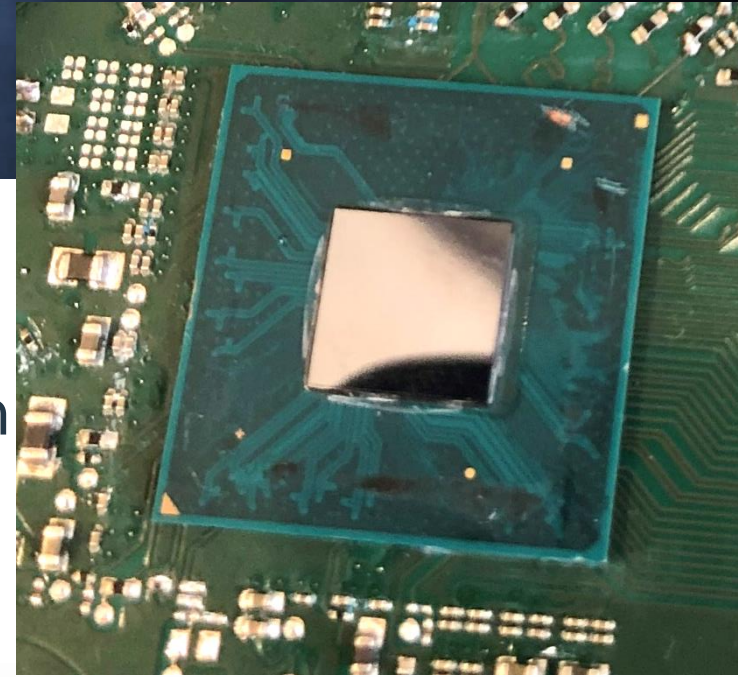
Fault injection

- ✓ Flip-chip packaging exposes die backside
 - Laser Fault Injection, Body Bias Injection, Electromagnetic Fault Injection
- x PCB is too big for our automatic XYZ positioning equipment
 - Likely cumbersome to do on a roof...

x No development kits

- Differential clock input
 - (But PLL?)
- Reset line
- Voltage Fault Injection

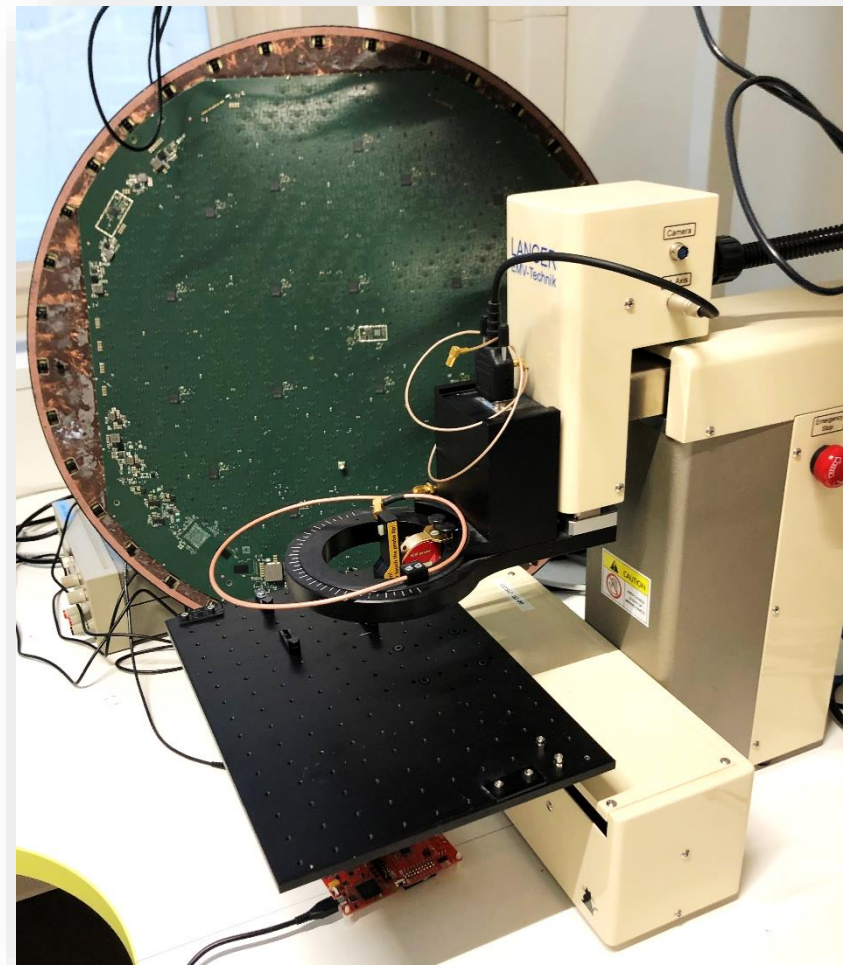
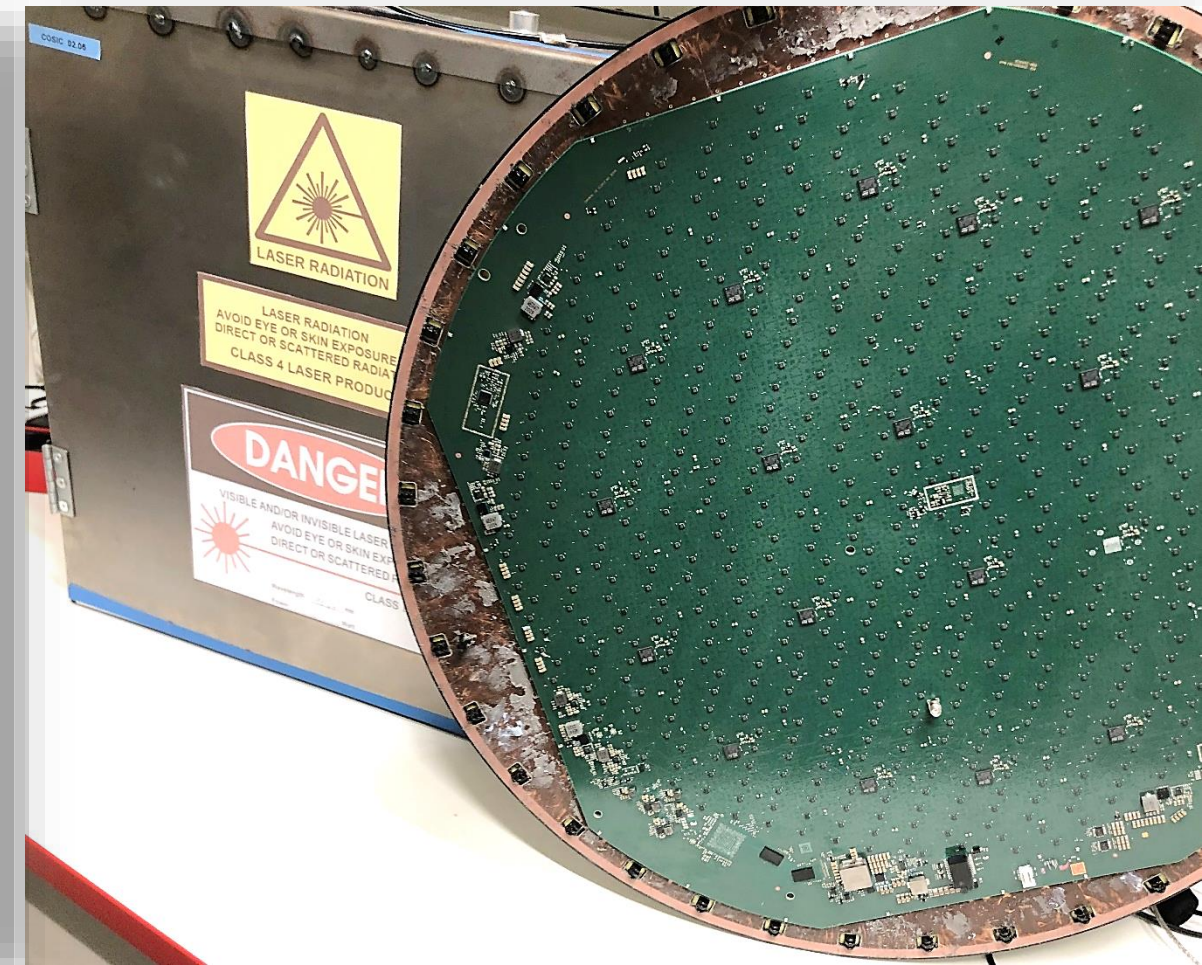
- NewAE ChipWhisperer-Lite (~ \$250)
 - Glitch port is connected to the SoC core voltage
 - Momentarily shorts core voltage to GND
- Core voltage: ~1V, generated by TI TPS56C230
- All decoupling capacitors untouched at this point!
- Oscilloscope triggers on serial data
 - Trigger output is input to the ChipWhisperer-Lite
- Glitch parameters controlled from Python
 - Offset from trigger point
 - Glitch width

- Replacing lab equipment with low-cost off-the-shelf components
- RPI Pico replaces oscilloscope and ChipWhisperer
- Works
 - But still messy...

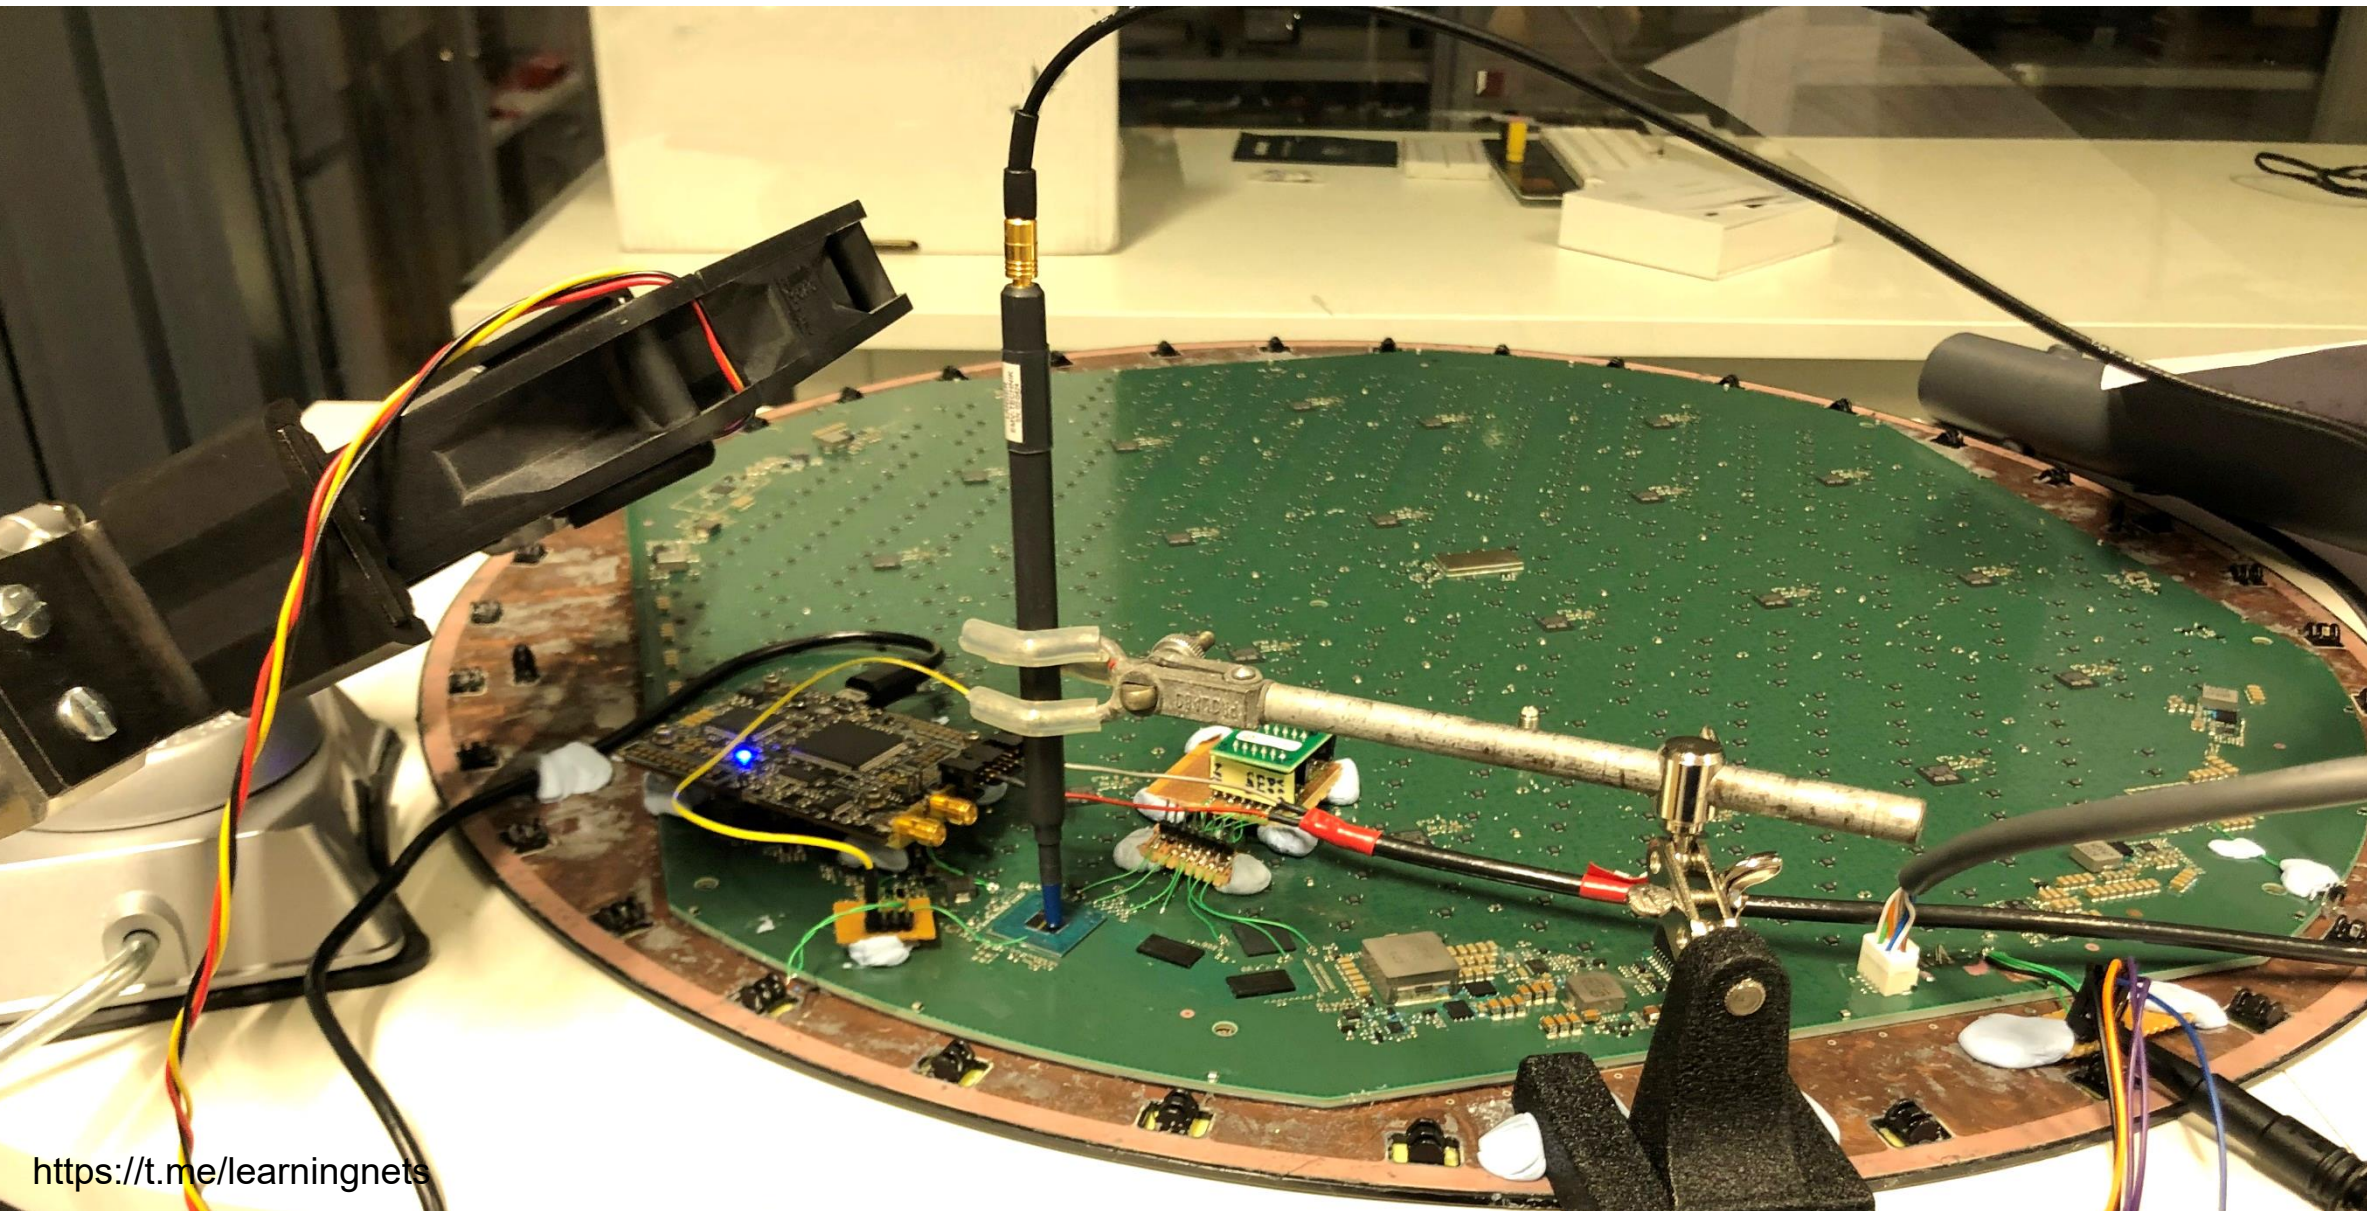
BL1 Glitch setup

- Try to boot with (in)valid signature, hash and firmware
- Try to glitch a valid certificate into a signature verification failure
