Glitched on Earth by Humans: A Black-Box Security Evaluation of the SpaceX Starlink User Terminal

Lennert Wouters

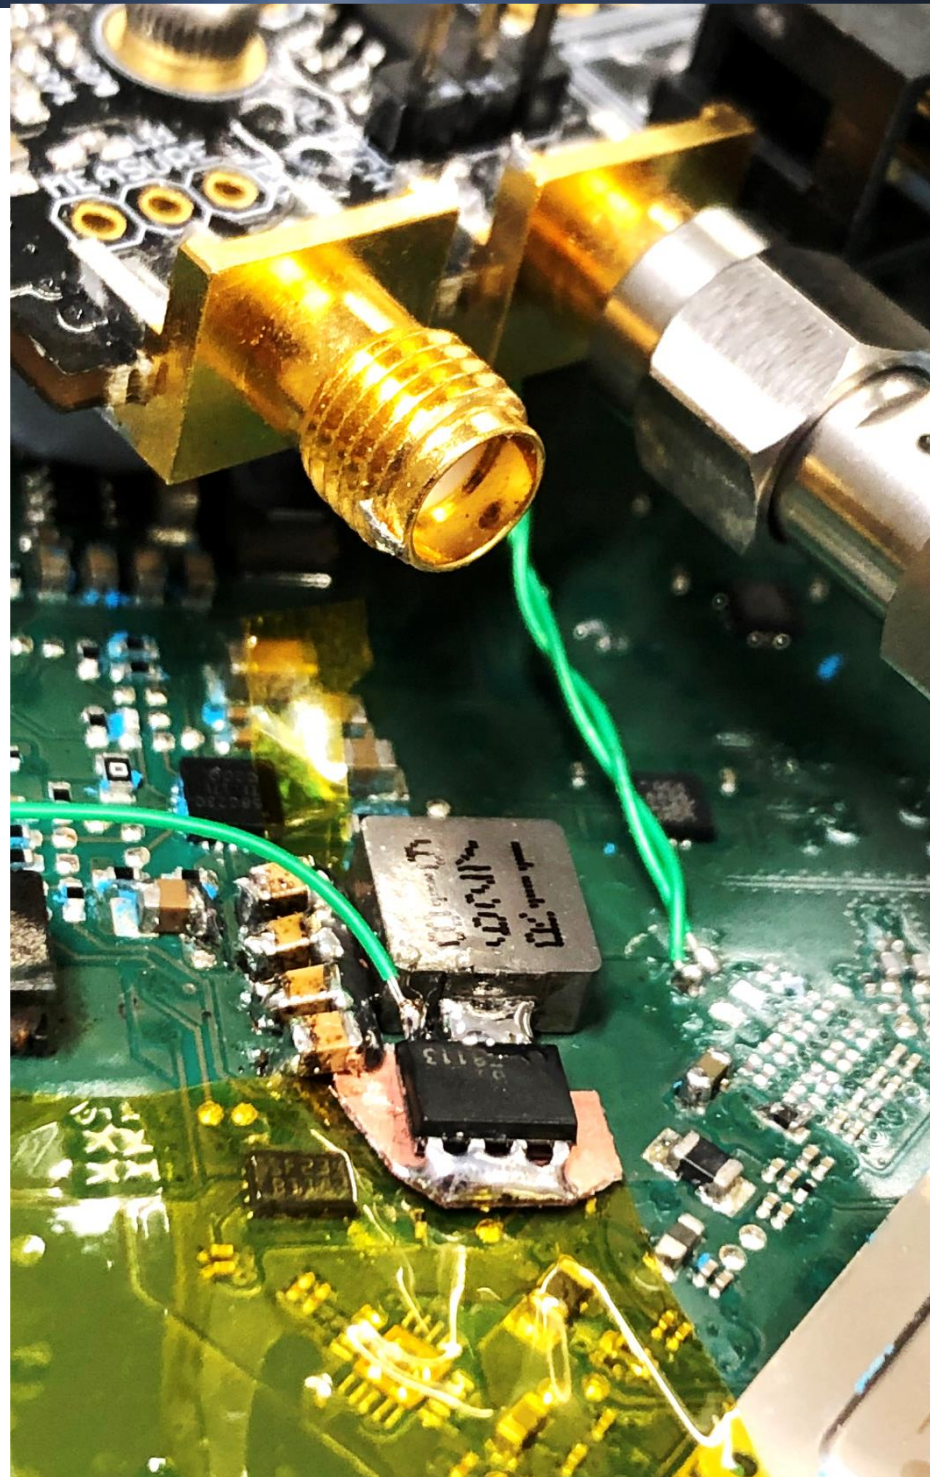
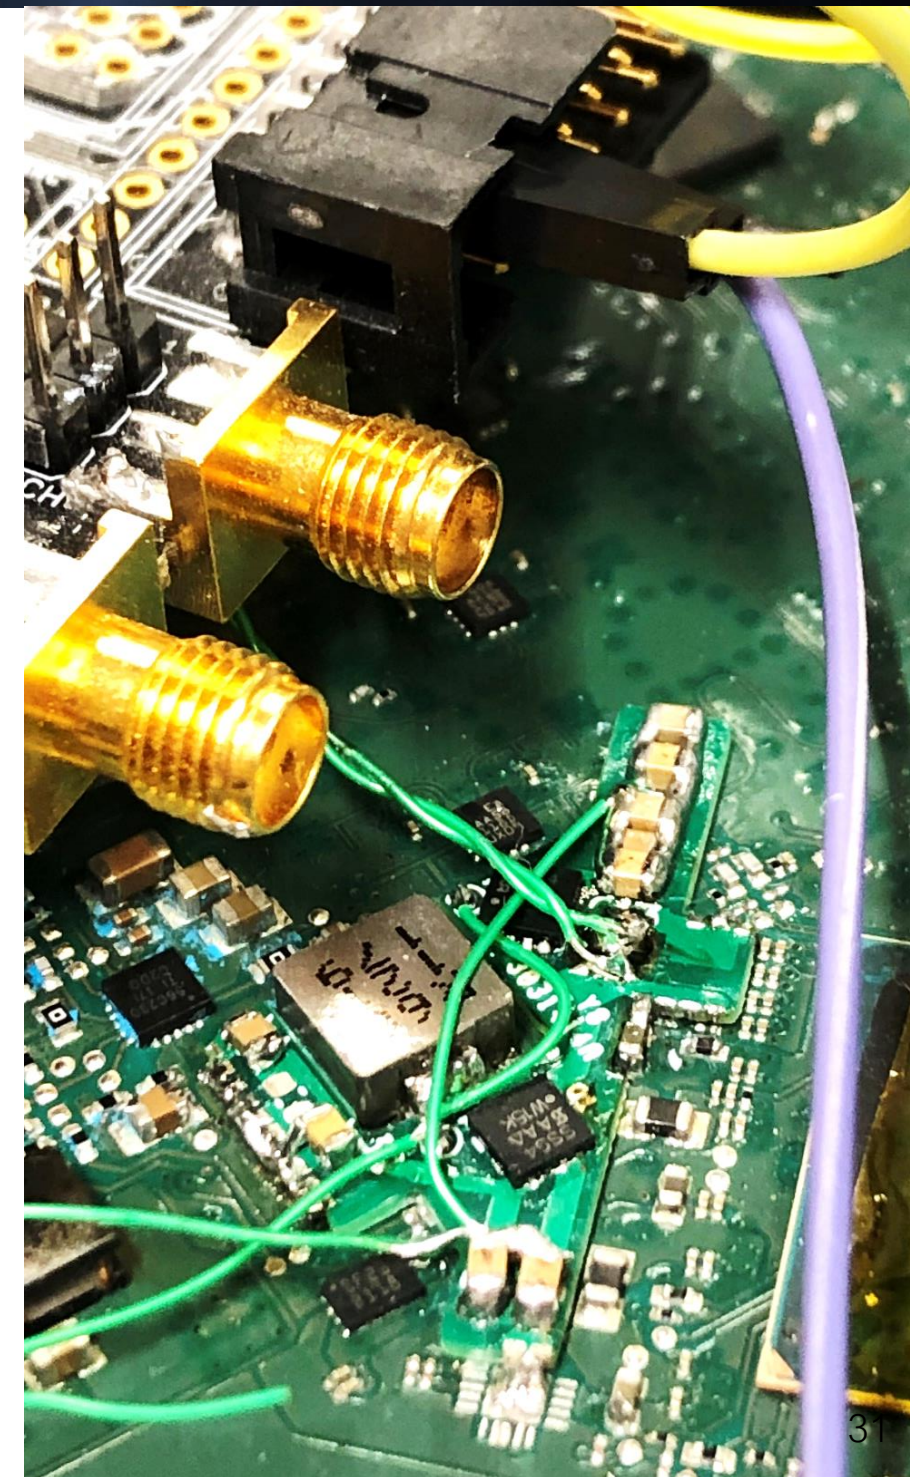
Enabling decoupling capacitors

- Decoupling capacitors are needed for later boot stages
- Experimented with:
 - N-channel MOSFETS
 - P-channel MOSFETS
 - High/Low side switching
 - Gate voltage
 - MOSFET drivers
 - Capacitor sizes
 - Timing

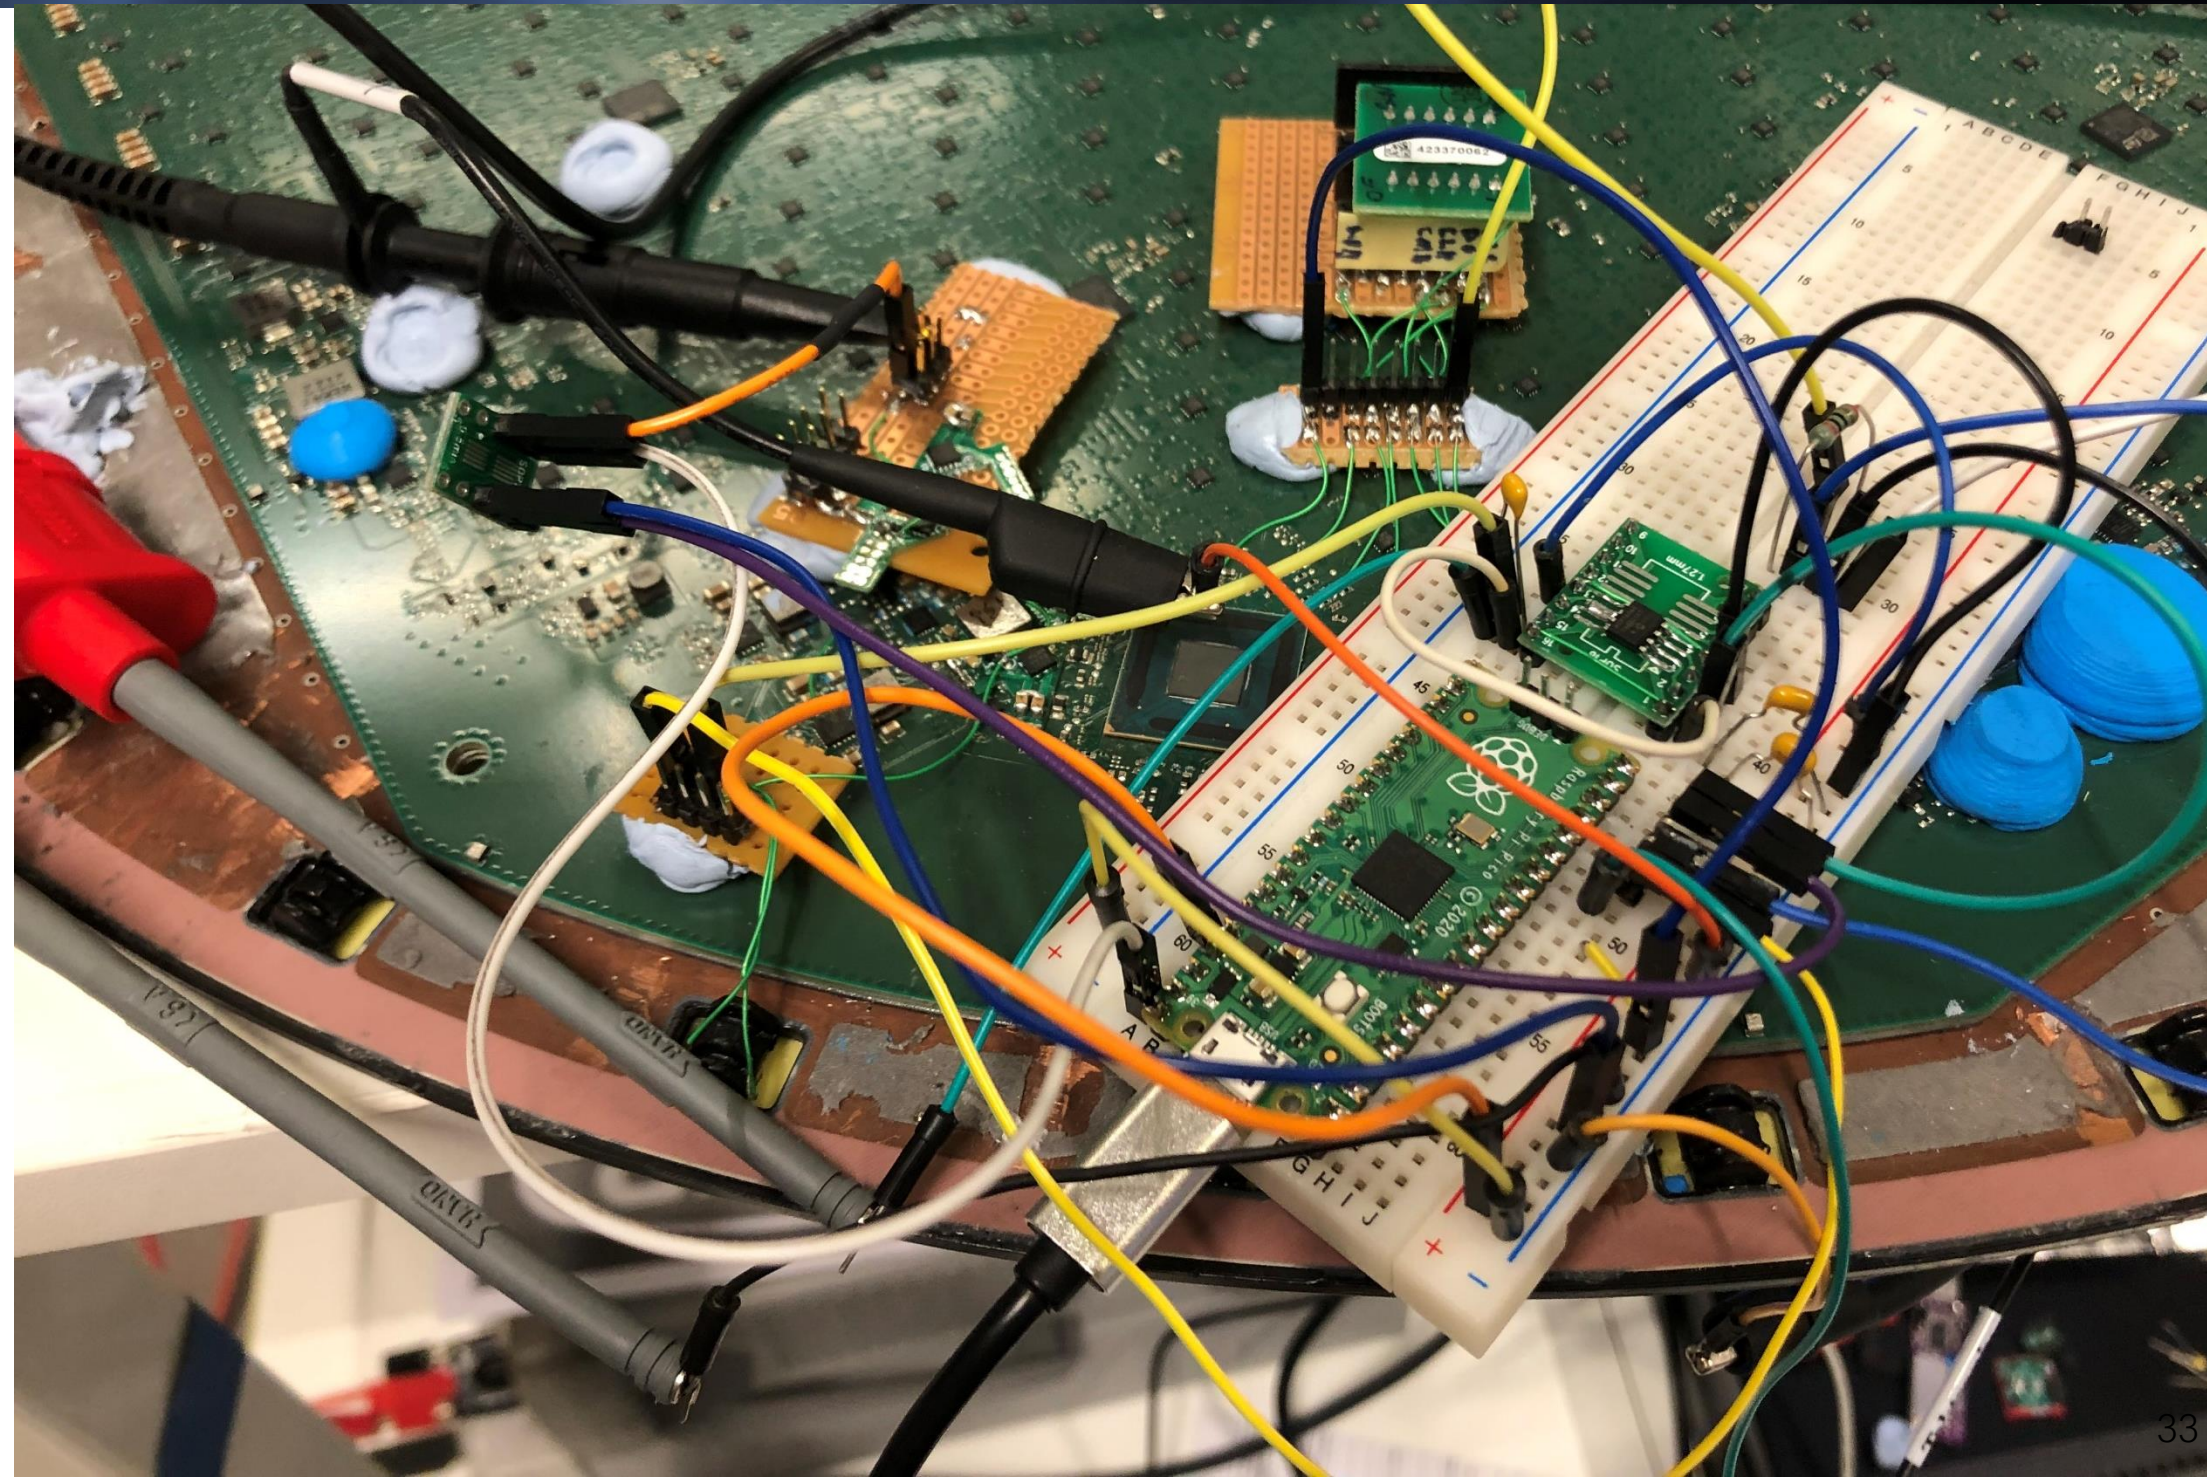
Creating a mobile setup

- Replacing lab equipment with low-cost off-the-shelf components
- RPI Pico replaces oscilloscope and ChipWhisperer
- Works
 - But still messy...

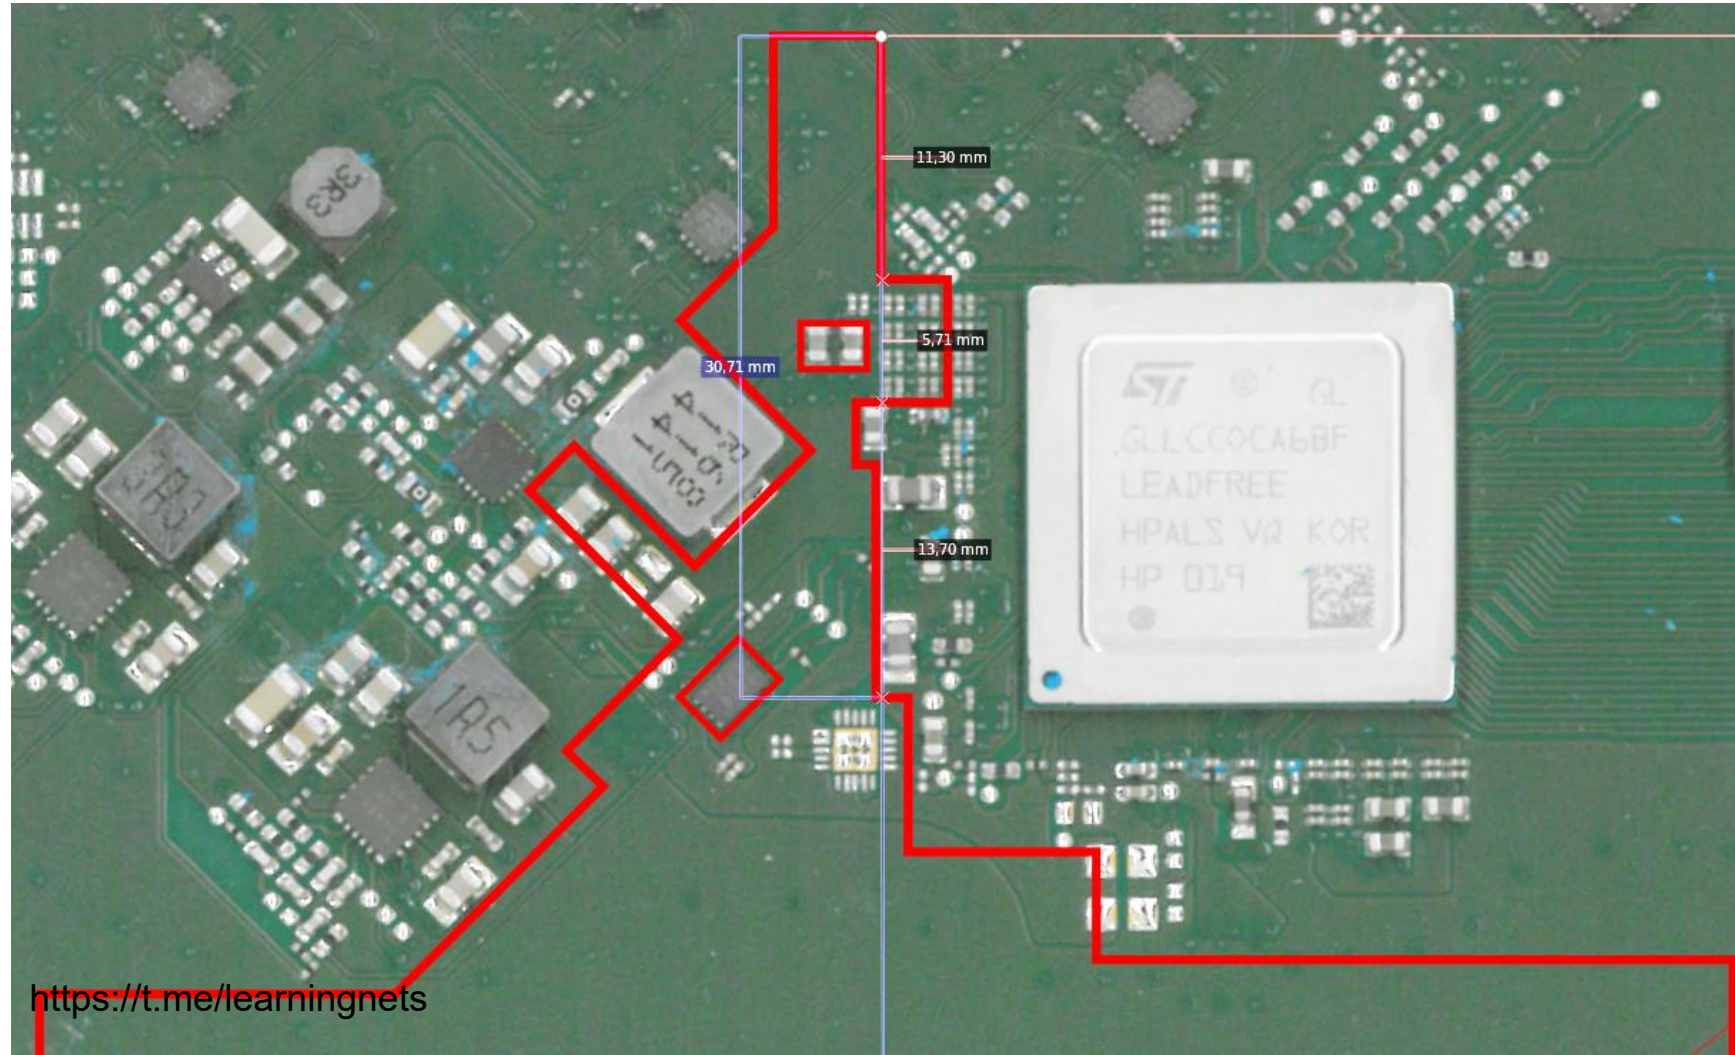
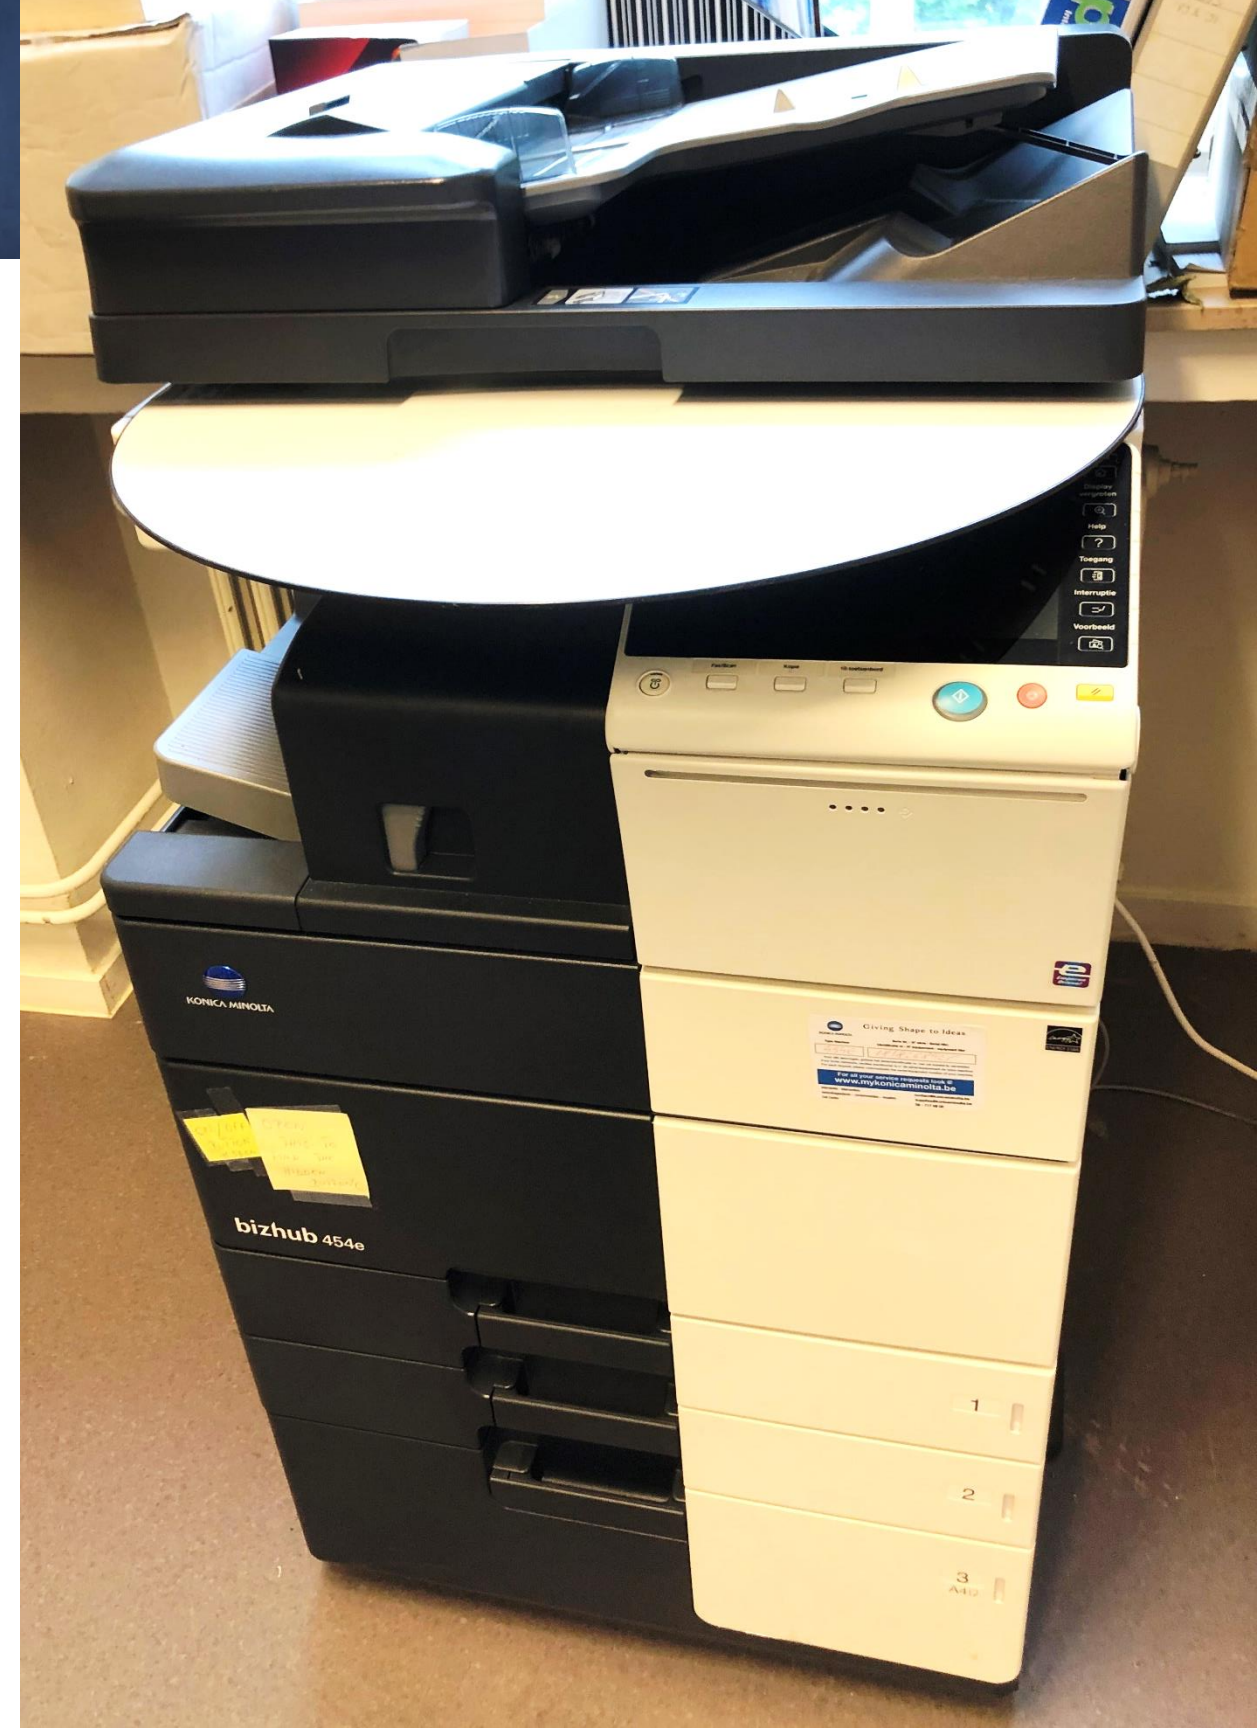
- Scanner @ 600 DPI
- Draw board outline at real size in Inkscape
 - Load in KiCad and use in the edgecuts layer

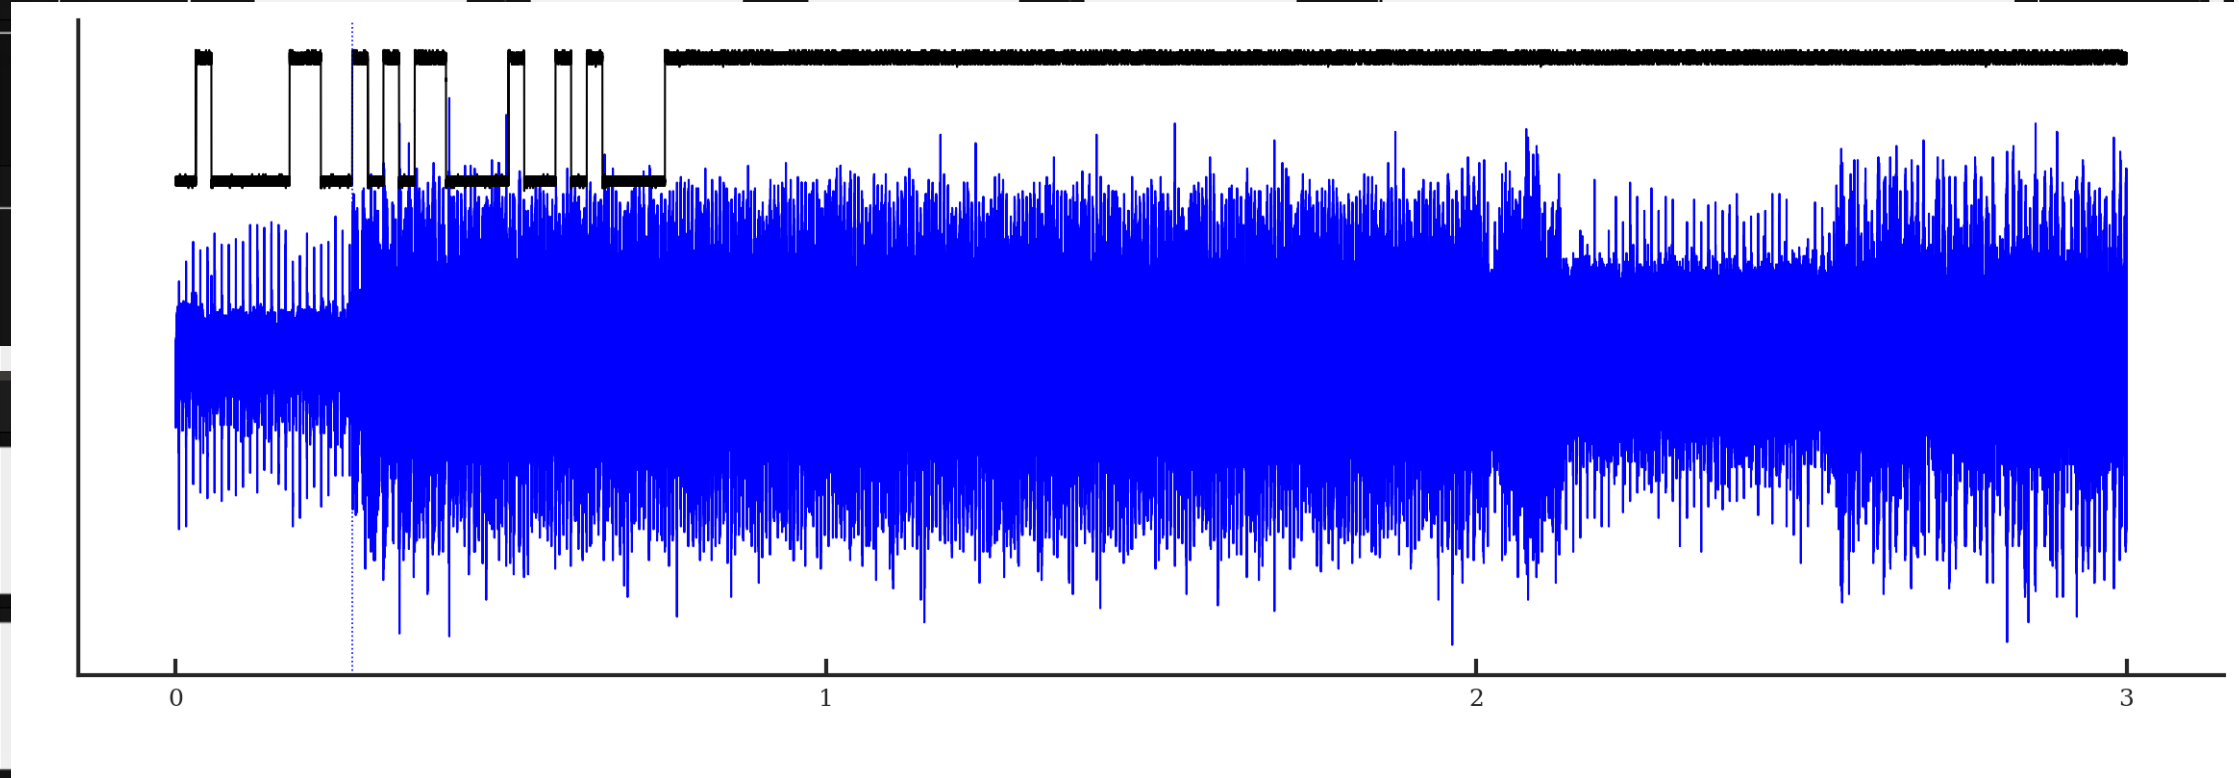
Adapt

- Trigger on eMMC D0 instead of UART
- Modchip could be easily adapted
 - Disconnect UT UART TX
 - Connect to eMMC D0
 - Update glitch parameters from Python
- Alternative: new PCB revision
