One Exploit to Rule them All?

On the Security of Drop-in Replacement and Counterfeit Microcontrollers

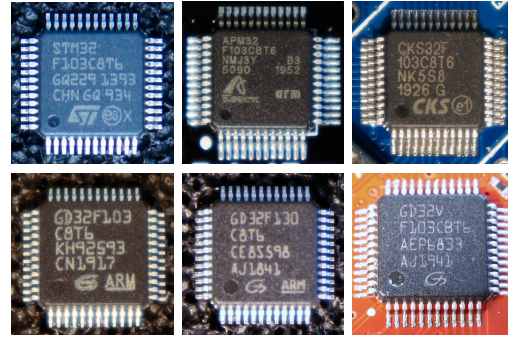
Figure 1: The Devices under Test, listed in Table 1.

For our analysis, we chose five replacements and an original device of the very popular STM32F103, a member of the STM32F1 family. They are shown in Figure 1 and listed in Table 1. In 2020, all these devices were available on the free market, sometimes advertised as STM32F103 drop-in replacements. The devices are based on an ARM Cortex-M3, except for the GD32VF103 that instead contains a RISC-V core. The GD32F130 is a special case as it does not have a direct STM32 counterpart; however, it appears to be a refined GD32F103 with additional capabilities, and most interestingly, extended security features. Thus, we analyze a broad range of devices from drop-in replacements to upgrades.

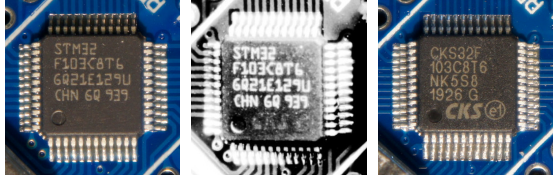
Figure 2: Under special illumination and image enhancements (center), the counterfeit STM32F103 (left) reveals the CKS marking of the actual chip (right).

While acquiring our devices under test (DuTs), we noticed that some vendors undercut the usual price of an STM32F103 by far; thus, we ordered a batch for analysis. Although components marked with STM32F103C8T6 were delivered, the debugger warned us that the IDCODE `0x2BA01477` does not match the expected value of `0x1BA01477`. Under strong illumination and by tilting the device, a very faint *CKS* marking appears, as shown in Figure 2. This part of the marking exactly matches an actual CKS32F103 device, hence, counterfeit STM32F103 with a manipulated marking were delivered. Thus, users have a risk of unintentionally employing counterfeit devices in their systems – including their vulnerabilities that we describe in the paper.

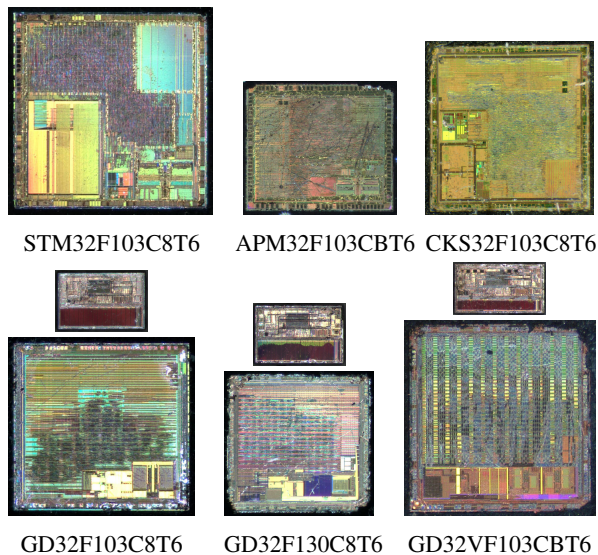
Figure 3: The silicon dies after decapping, true to scale; the exact dimensions are listed in Table 3 in Appendix A.

The chips, shown in Figure 3, are very different from each other, thus, all of them are individual developments. The sizes of the dies vary widely, as listed in Table 3 in Appendix A, even hinting at different manufacturing technologies. The GD32 devices contain two dies in their package which was seldom observed in microcontrollers. Further analysis showed, in accordance with other analyses [12, 21], that the smaller chip contains the flash memory and the larger one incorporates the remaining logic such as the CPU, SRAM, and peripherals.

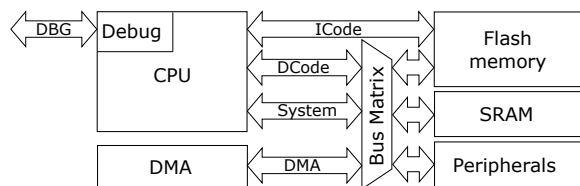
Figure 4: Simplified block diagram of the internal buses of a typical microcontroller.

system, a multitude of components is connected to the internal buses, as shown in Figure 4. The debug module, the CPU, and the Direct Memory Access (DMA) module are masters on the buses, thus, they can perform read-transactions from flash memory. For that, we test whether in RDP level 1,

As illustrated in Figure 4, the flash memory on an ARM Cortex-M based device is accessed via the data bus and instruction bus. The data bus serves data and debug accesses; the instruction bus is intended for instruction and interrupt vector fetches from flash memory [2].

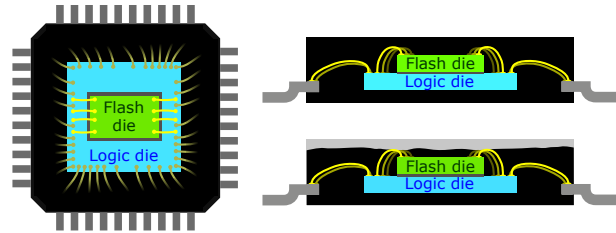
Figure 6: Top and side view of a dual-die device. The bonding wires between both dies become accessible by partially removing the casing (right, bottom).

All tested GD32 devices have a separate logic and flash memory die, as shown in Section 4.3. Both chips are stacked atop of each other and connected via bonding wires, illustrated in Figure 6. This sparked the question, whether such a design is sufficiently secure against invasive physical attacks – especially in the case of the GD32F130 that did not exhibit any debug interface vulnerabilities so far.

In order to gain access to the bonding wires for eavesdropping, the top of the casing is carefully removed via sand paper of 120 and 600 grit size. A small portion of the bonding wires' top curvature becomes sufficiently accessible to contact it momentarily with a very thin wire. Without requiring a pre-amplifier, these signals are connected to a logic analyzer.

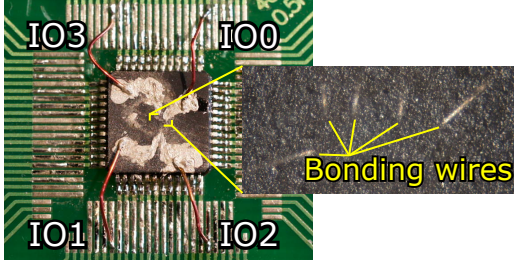
Figure 7: The prepared GD32F130 with access to all four QSPI data signals (IO0 to IO3).

To create a larger, electrically improved, and mechanically more stable contact area for further analysis, we applied conductive silver paint. A fine brush, manually made from a sin-

gle fiber of a bamboo stick, is helpful to apply the paint. Via additional thin wires, all four QSPI signals are permanently connected to the circuit board. The result of this rather tedious task is shown in Figure 7. Due to the regular communication pattern and availability of a datasheet of a functionally similar standalone QSPI flash device by GD [8], no additional signals need to be probed for reverse-engineering.

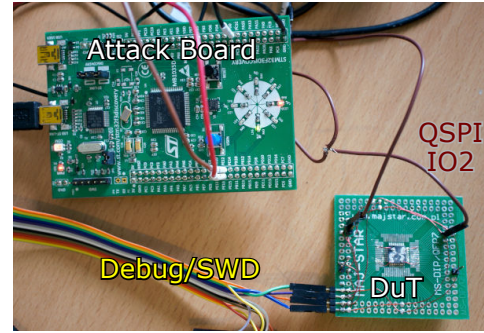
Figure 8: QSPI active manipulation setup with transaction excerpt. A fault (red) is injected into the IO2 signal to alter the option bytes, aligned to the distinct pattern (yellow) at the end of the bootloader.

showed that the RDP setting is loaded during startup and present on the bus in plain without obfuscation. The naive approach would be to interfere with the option byte loading by directly manipulating the option byte transmission. Downgrading from RDP level 2 to 1 to re-enable the debug interface is feasible by flipping any bit, however, this does not provide access to the firmware as no debug interface vulnerabilities are known for level 1. To downgrade from level 2 to 0, the option bytes would have to be altered from 0xCC33 to 0xA55A. While being at least theoretically possible, this would again require access to all four QSPI data signals at once.

The reason for this is unknown but it enables a new attack vector. Further analysis shows that the factory configuration is loaded from address 0x0400 and the option bytes are loaded from address 0x4000. Thus, by manipulating the *address* of the QSPI transaction loading the option bytes, they are forced to be loaded from the factory configuration region instead. This replaces the actual option bytes with the value 0xA55A and the device falls down to RDP level 0 – enabling full access to the entire user firmware via the debugger.

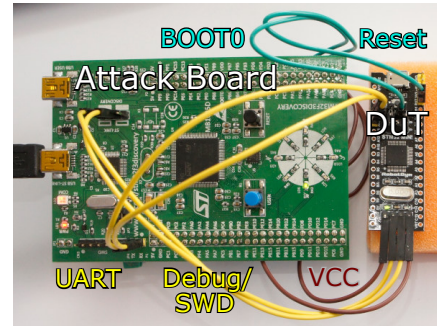
Figure 9: The setup for glitch generation, boot mode selection, and code extraction.

For the attack, we setup the DuT as shown in Figure 9. At first, we upload a two-stage exploit firmware to the SRAM with a debugger and shut down the debugger afterwards. Next, we configure SRAM-booting via the BOOT pins.

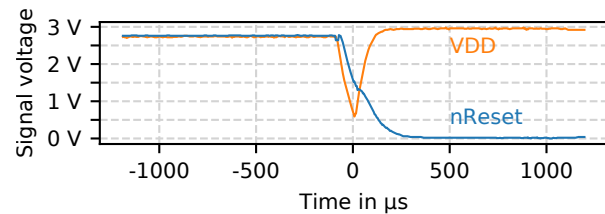
Figure 10: The VDD/supply glitch triggers a system reset.

However, the flash memory is still locked down since a debugger was connected. To release the lock down, we perform a very quick power cycle by cutting the power supply for a few hundreds of microseconds. During that glitch, we observe the microcontroller's reset line to detect when the system goes into reset. At this moment, our setup automatically restores power, as shown in Figure 10. After this very short power-cycle, access to the flash memory is re-enabled. But due to SRAM data remanence [18], such a short interruption in the power supply leaves the data in SRAM intact.
